# Preliminary Ignition Investigation Report

<b>Ignition Database Index:</b>	20240875N
<b>Electric Incident Investigation (EII) Number:</b>	N/A
<b>Incident Name:</b>	Rocky - 06 Jul 2024
<b>PG&amp;E Facility Ignition?</b>	Yes
<b>CPUC Reportable Ignition?</b>	Yes
<b>Date &amp; Time of Incident:</b>	July 6, 2024, at 0351 hours <sup>1</sup>
<b>Street Address:</b>	Old Gulch Road and Rocky Road
<b>City:</b>	San Andreas
<b>County:</b>	Calaveras
<b>Latitude/Longitude:</b>	38.1753471926, -120.5895900754
<b>State Responsibility Area (SRA) / Local Responsibility Area (LRA) / Federal Responsibility Area (FRA)</b>	State Responsibility Area (SRA)
<b>PG&amp;E Division:</b>	Stockton
<b>High Fire Threat District (HFTD):</b>	Tier 2
<b>High Fire Risk Area (HFRA):</b>	Yes
<b>EPSS Buffer:</b>	No
<b>Fire Index Area (FIA):</b>	320
<b>Fire Potential Index (FPI) Rating: FIA</b>	R4
<b>Fire Potential Index (FPI) Rating: Circuit</b>	R4
<b>Was there a PSPS event at the time of ignition?</b>	No

<b>Suspected Initiating Event:</b>	Vegetation
<b>Failure Driver:</b>	Contact from Object
<b>Failure Sub-driver:</b>	Contact – Vegetation
<b>Circuit:</b>	Calaveras Cement 1101
<b>Circuit Protection Zone:</b>	Calaveras Ce

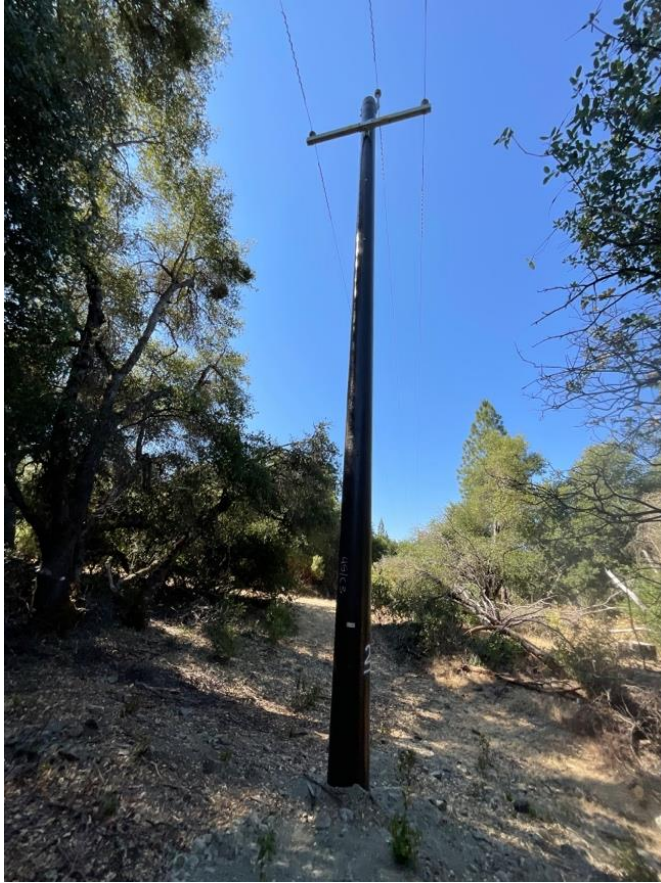
<b>Load Side Structure</b>	104174502	
<b>Info / Inspection</b>	<b>Most Recent Date</b>	<b>Findings</b>
Install Date:	May 8, 2023	45-foot Class 3 fiberglass pole
Inspection:	June 30, 2023	Inspector noted birdcaging at a splice on the primary conductors, created EC notification no. 126486820. No issues found with pole, framing, or vegetation (Figure 10).
	May 14, 2020	Last enhanced GO165 inspection for ancestor pole SAP ID 101280386.
Corrective History:	June 30, 2023	EC notification no. 126486820 (priority E) created to repair birdcaging at a compression splice on the primary conductors. Current pole was installed May 8, 2023, but due to outdated photos from iHawk taken on April 5, 2023, pole was re-flagged for replacement. Work was not complete at the time of the ignition incident.
Aerial Inspection Records:	January 31, 2024	"Conductor bird caging at splice." (Figure 11) No other abnormal conditions noted.

*Figure 10. Pre-incident photo of load-side pole (SAP ID 104174502) from recent inspection (taken June 30, 2023).*
