Preliminary Ignition Investigation Report

Ignition Database Index:	20240309 (Index 309) 20240309N (Index 309N)
Electric Incident Investigation (EII) Number:	NR240420A – 309 N/A – 309N
Incident Name:	Blackberry – 309 N/A – 309N
PG&E Facility Ignition?	Yes – 309 and 309N
CPUC Reportable Ignition?	Yes - 309 and 309N
Date & Time of Incident:	April 20, 2024 @ approximately 1416 hours
Street Address:	Deer Creek Hwy (HWY 32) & Blackberry Road – 309 Deer Creek Hwy (HWY 32) & Eagle Ridge Drive – 309N
City:	Forest Ranch
County:	Butte
Latitude/Longitude:	39.83563, -121.69607 – 309 39.84403, -121.694526 – 309N
State Responsibility Area (SRA) / Local Responsibility Area (LRA) / Federal Responsibility Area (FRA)	State Responsibility Area – 309 and 309N
PG&E Division:	North Valley – 309 and 309N
High Fire Threat District (HFTD):	Tier 3 – 309 and 309N
High Fire Risk Area (HFRA):	Yes – 309 and 309N
EPSS Buffer:	N/A
Fire Index Area (FIA):	280 – 309 and 309N
Fire Potential Index (FPI) Rating: FIA	280

Fire Potential Index (FPI) Rating: Circuit	R1
Was there a PSPS event at the time of ignition?	No – 309 and 309N
Suspected Initiating Event:	Contact – 3 rd party – 309 Equipment – PG&E – 309N
Failure Dr

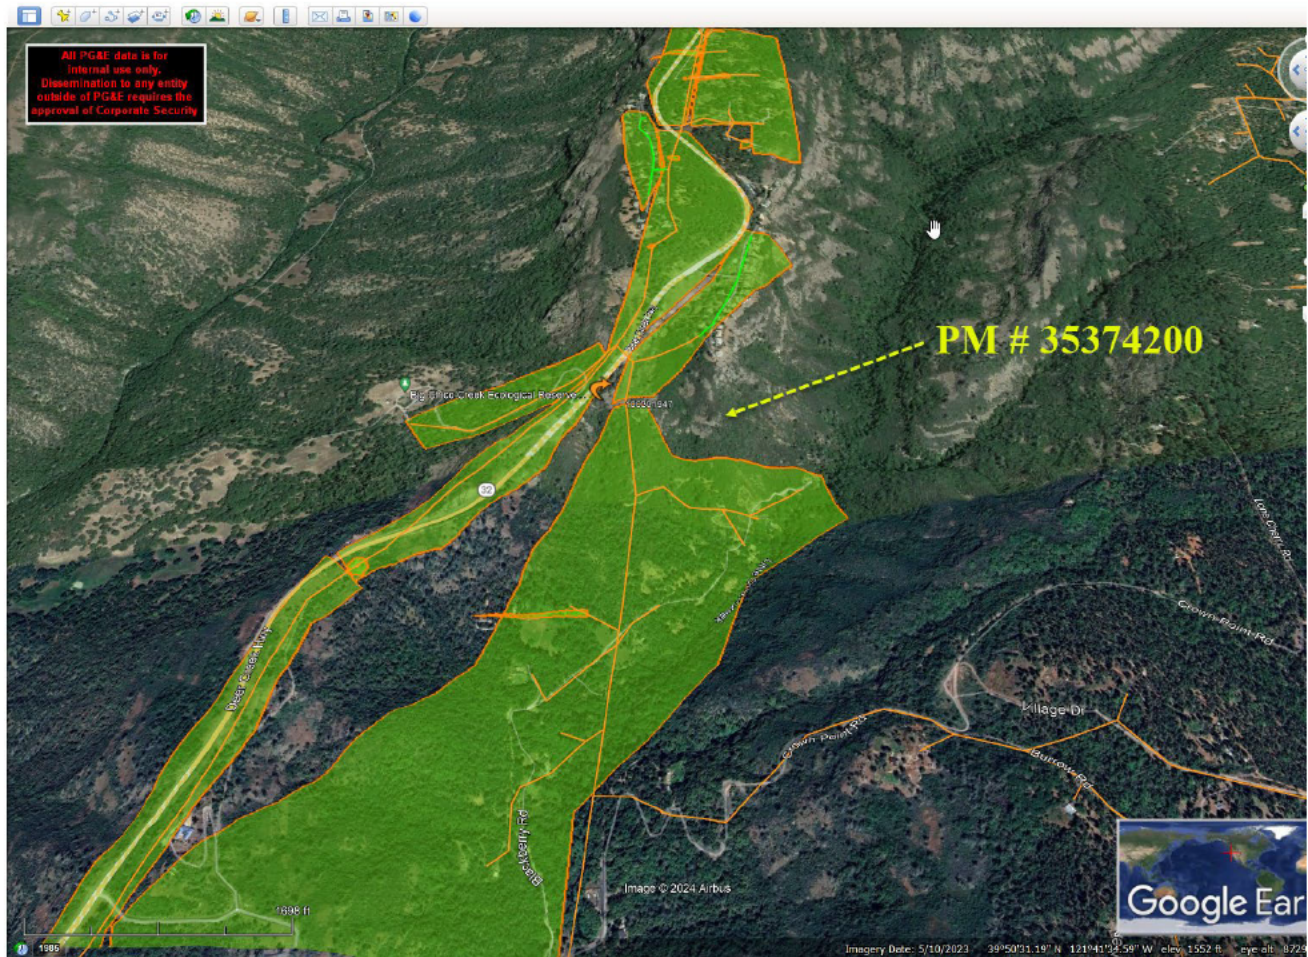
Figure 11 Google Earth Pro Map showing polygons for undergrounding projects. Both Incident Location are scoped into PM # 35374200, with a completion date of August 21, 2025.
