**PACIFIC GAS AND ELECTRIC COMPANY**  
**Wildfire Mitigation Plans Discovery 2022**  
**Data Response**

PG&E Data Request No.:	CalAdvocates_025-Q06		
PG&E File Name:	WMP-Discovery2022_DR_CalAdvocates_025-Q06		
Request Date:	July 8, 2022	Requester DR No.:	CalAdvocates-PGE-NonCase-2022WMP-25
Date Sent:	July 13, 2022	Requesting Party:	Public Advocates Office
PG&E Witness:		Requester:	Holly Wehrman

Questions 6-7 relate to PG&E's response to Critical Issue RN-PG&E-22-06.

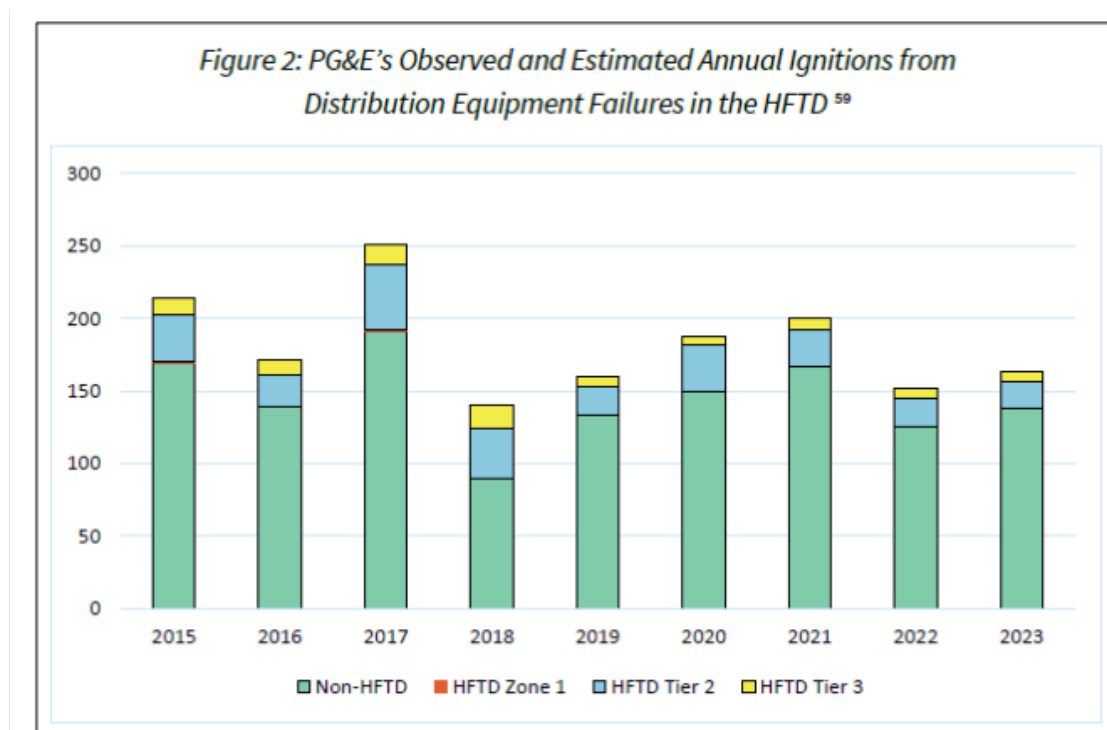
Page 16 of Energy Safety's Revision Notice includes the following chart, which shows a steady increase in non-HFTD ignitions from 2018 through 2021:

- a) Please list all causal factors to which PG&E attributes the increase in equipment-related ignitions from 2018 to 2021 in *non-HFTD*.
- b) Please list and briefly describe all actions PG&E is taking in 2022 to reduce the number of equipment-related ignitions in *non-HFTD*.

- a) Given the relatively modest year-to-year changes from 2018 to 2021, we believe this annual increase is likely due to random year-to-year variability in the number of ignitions, and not necessarily be representative of an underlying trend. Indeed, when comparing the ignition counts for the other years in the dataset, PG&E observed less equipment-related ignitions on average in the three years after 2018 (123) than the three years preceding it (139), despite the consistent annual increase in ignitions from 2018 to 2021.
