TD-2305M-JA02. Rev. 11

## Summary

This job aid is designed to assist Electric Distribution Compliance Inspectors, PG&E Employees, and Contractors in assessing and prioritizing compelling abnormal conditions on overhead facilities, including but not limited to GO 165 Inspections. Compelling Abnormal Condition is defined as any electric distribution pole, equipment, component, conductors, vegetation, or thirdparty condition that causes a safety or fire ignition risk that, in the judgment of the field employee, may adversely impact public safety and/or service reliability within 5 years.

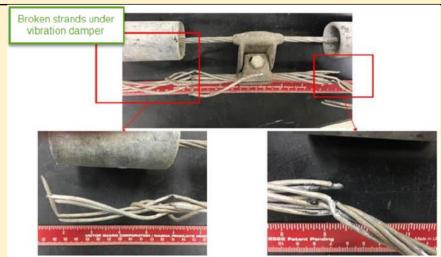
At this Location: Broken strands (more than 40%) under vibration Damper

FDA = Conductor / Broken / Damaged / Replace

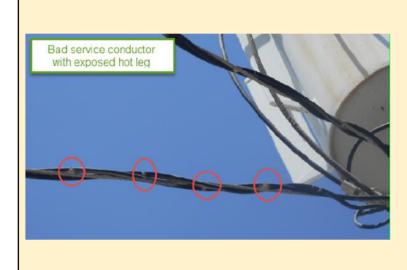
#### Bad service conductor with exposed hot leg

At this Location: Bad service conductor with exposed hot leg, bundled with a potential to cross phase

FDA: FDA = Conductor / Broken /

Damaged / Replace

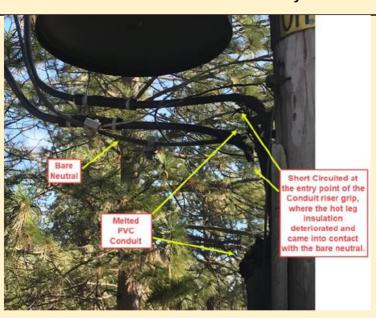
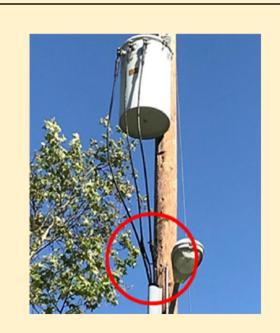
## **Secondary Service Riser Drops**

At this Location: hot leg insulation frayed at the point of entry point of the molding exposing the conductor into contact with the neutral

FDA=Conductor / Broken / Damaged / Replace

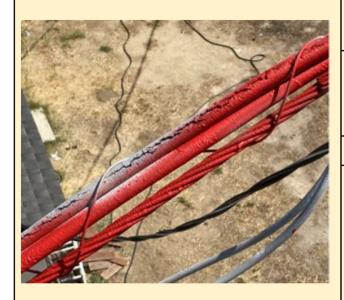
## Damaged / Cracked Grey Service

At this Location: Cracked grey service / Aerial cable. Older grey services tend to crack and will appear to have rings around the insulation. Loose lashing, visually cracked, discoloration/corrosion, Degradation.

Must be carefully evaluated. Call lead or supervisor.

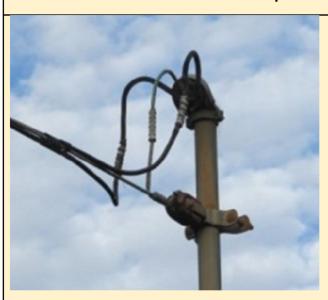
#### **Exposed Service Connector**

At this Location: Exposed Conductors, with an acceptable air gap between conductors

FDA= Conductor / Broken / Damaged / Repair

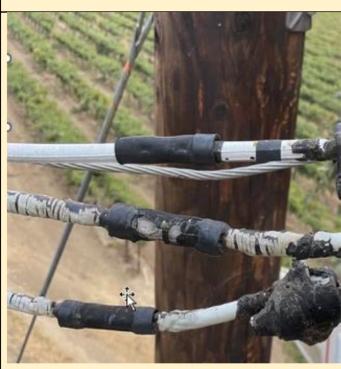
#### **Cracked Grey Service and Deteriorated Insulation Tape**

At this Location: Deteriorated cracked Grey service for potential cross-phasing

FDA= Conductor / Damaged / Replace FDA= Connector/ Insulation Deteriorated / Repair

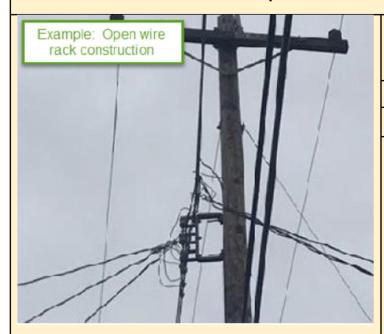
#### **Open Wire Rack Construction**

At this Location: Span length >135' missing spreader bracket for open wire extended rack construction.

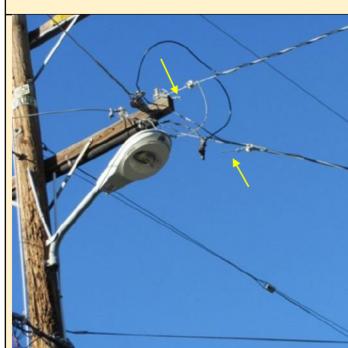
#### Hardware Broken

At this Location: The #6 solid copper is broken causing strain on the conductor. Unsecured service.

**FDA=** Hardware / Framing / Broken / Damaged / Repair

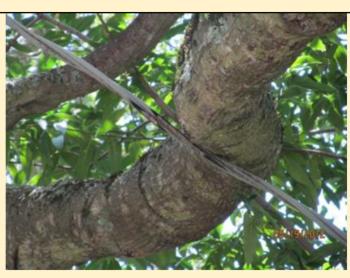
At this Location: Service strain abrasion, with possible burning at some sections. Damaged insulation.

**FDA =** Conductor / Broken / Damaged Repair or Replace

**Priority =** E Tag, 3-12 months depending on exposure, in comments add note about strain abrasion burnt conductor

If abrasion has caused an exposed hot leg, assign Priority "A", emergency, and stand-by.

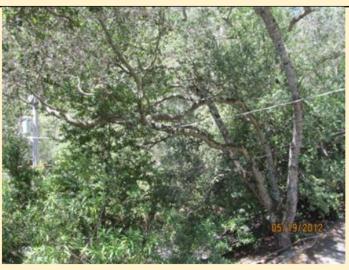
At this Location: Service strain abrasion, no slack remaining

**FDA =** Conductor / Broken / Damaged Repair or Replace

**Priority =** E Tag, 3-12 months depending on exposure, in comments add note about strain abrasion burnt conductor

If abrasion has caused an exposed hot leg, assign Priority "A", emergency, and stand-by.

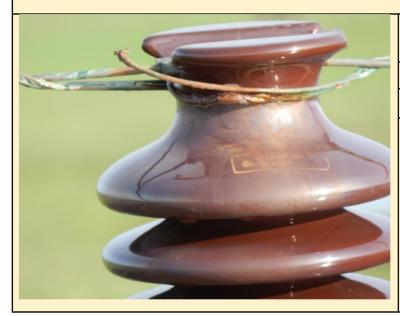
#### **Tie Wire Corroded**

At this Location: Tie wire is corroded, strand is broken

FDA=Tie Wire / Corroded / Replace

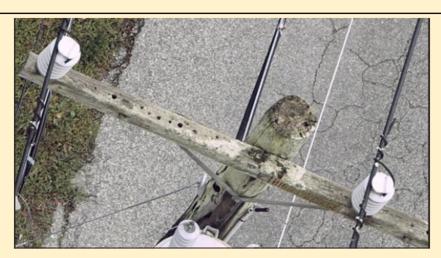
## **Broken / Corroded Tie Wire**

At this Location: Broken tie wire

FDA = Tie wire / Broken / Damaged / Repair / Replace

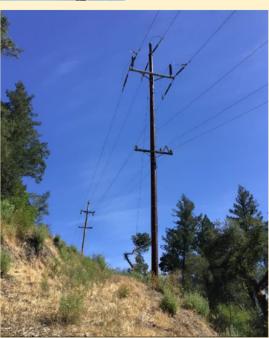
**At this Location:** Not obvious if it's still attached, Transmission with distribution under-build, in HFTD. Insulator has spun.

FDA = Tie wire / Broken / Damaged / Repair / Replace

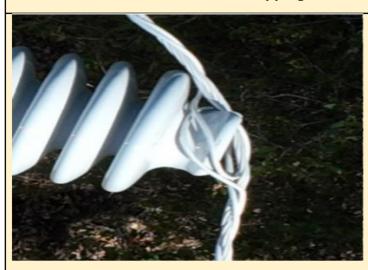
## Tie Wire Slipping and Coming Loose, Angle Pole

At this Location: Tie wire is slipping from an inside angle

**FDA=** Tie wire / Broken / Damaged / Repair / Replace

**Priority =** A Tag, Follow the emergency procedure

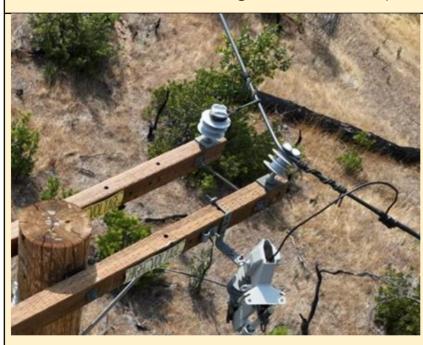
## Angle Pole with Tie wire, Bent Steel Pin

At this Location: Angle pole with post top insulator, where the inside angle insulator conductor is only being supported by tie wire (non-clamped). Post top insulator steel pin is bent

FDA= Tie wire / Broken / Damaged /

Repair / Replace

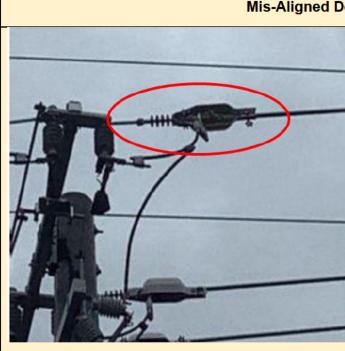
## Mis-Aligned Dead-End Covers

**At this Location:** Dead-End Cover mis-aligned on tree wire construction.

**FDA=** Dead End Cover / Broken / Damaged / Replace

- 4. Primary Covered Conductor "Tree Wire"
  - A. Dead-End Covers Mis-aligned General Guidance: If Dead-End Covers are:
    - Rotated or mis-aligned
      - That have caused energized portions of the conductor that could be exposed to vegetation or animal contact, at a location of risk, and not meeting its purpose.
        - Rotated beyond the plane from level of the conductor, 45 degrees or more.
    - Appear that it was installed and now missing. Tree Wire **Only**.

If observed, create EC Notification to repair (Installed Dead-End Cover with Anti-Rotation Clamp) or replace dead-end cover

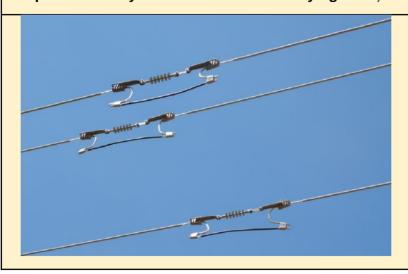
## Exposed Primary Covered Conductor – Flying Bells, Wedge Connectors not removed after Work

At this Location: Flying Bells installed in on primary tree wire, now have exposed connectors and conductor.

FDA: Tree Wire / Exposed / Repair

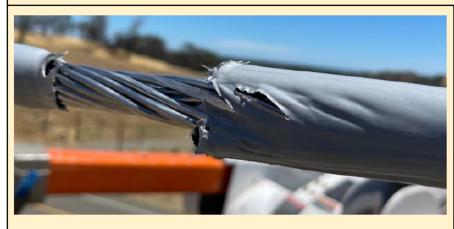
## **Exposed Primary Covered Conductor Tree Wire**

At this Location: Tree Wire jacket cut into, and bare conductor exposed

FDA: Tree Wire / Exposed / Repair

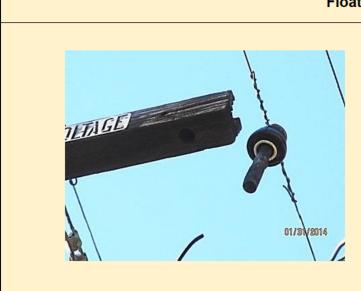
#### Floater

At this Location: Floater, conductor is not contacting the arm. Rotten crossarm.

FDA=Crossarm / Decayed/Rotten/

FDA= Conductor / Floater / Repair

General Guidance: Does primary or secondary conductor(s) float? A floater is when the conductor is not attached to the crossarm/pole. Floaters are ALWAYS an Emergency/Standby condition. Create EC Notification using FDA Conductor / Floater / Repair.

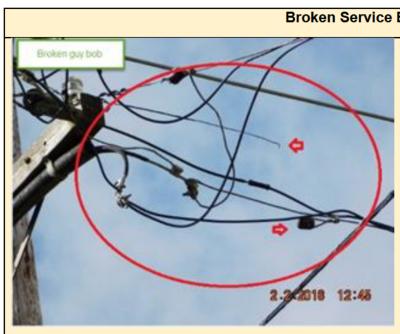
#### **Broken Service Bob**

At this Location: Broken service Insulator which has become unattached between the copper wire and the insulator.

FDA= Hardware/Framing / Broken / Damaged / Repair

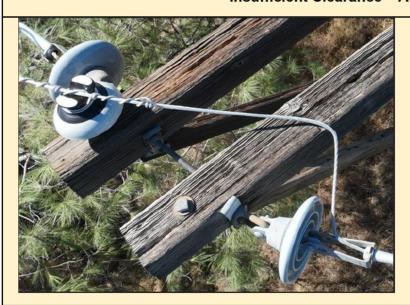
#### Insufficient Clearance - Aerial View

At this Location: Over the top jumper

laying on cross-arm

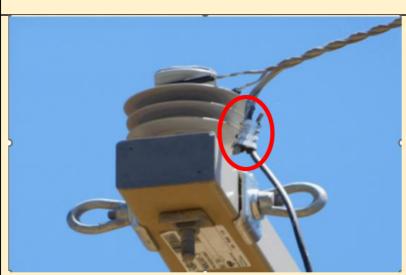
## **Insufficient Clearance**

At this Location: Insufficient clearance between connector and cross-arm

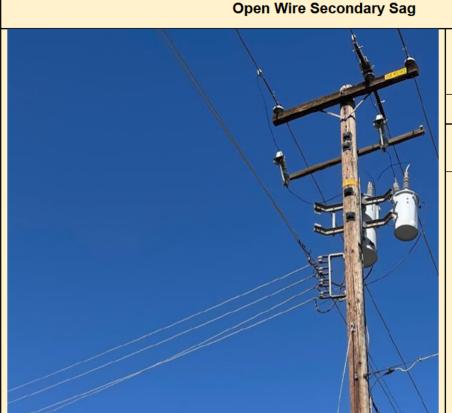
At this Location: Open wire secondary sag into neutral, energizing the neutral

**PRIORITY=** A tag, follow emergency procedure

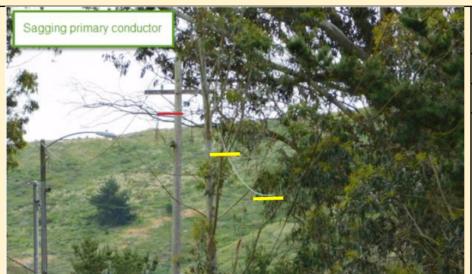
## **Primary Sagging Conductor**

At this Location: Sagging

**Primary Conductor**

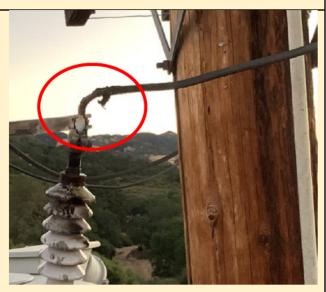
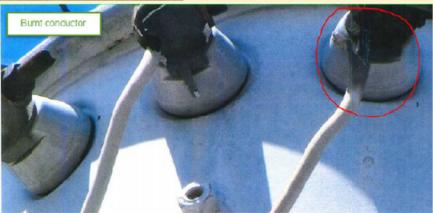
## Burnt Jumper

**At this Location:** Primary jumpers and / or transformer secondary connection jumpers frayed and burnt.

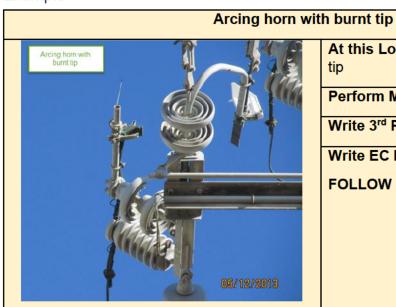
# At this Location: Arcing horn with burnt

tip

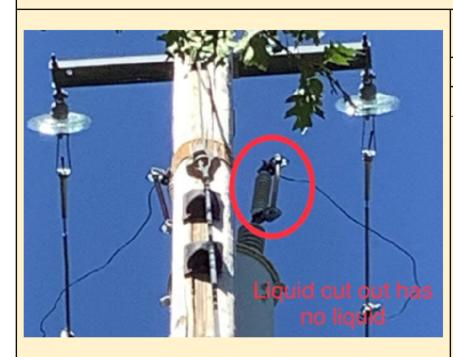
## Liquid Fuse with no Liquid

At this Location: Liquid Fuse with no liquid, not in HFTD

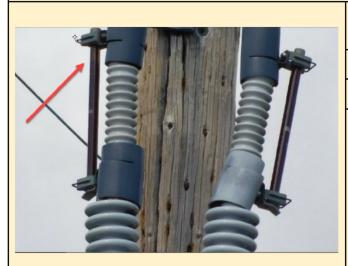
## Liquid Fuse Oil Level is Low

**At this Location:** Liquid Fuse with low oil level in HFTD area.

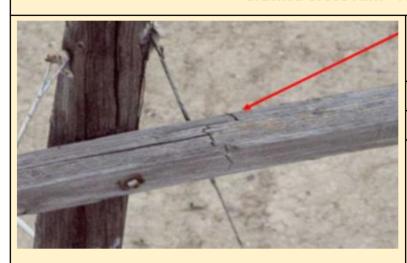
#### Cracked Cross-Arm - Aerial View

At this Location: Top view of a cracked cross-arm on top and sides. May not be seen from the ground.

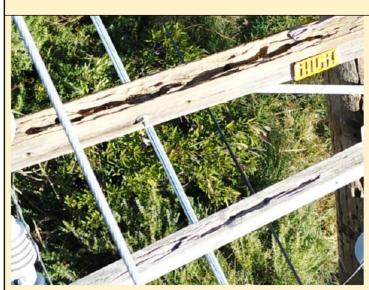
## Deteriorated Cross-Arm - Aerial View

At this Location: Deteriorated Cross-Arm – Aerial View

**Priority =** Minimum B tag 0-3months, consider A Tag for conditions such as conductor size, double / single arm, exposure, etc.

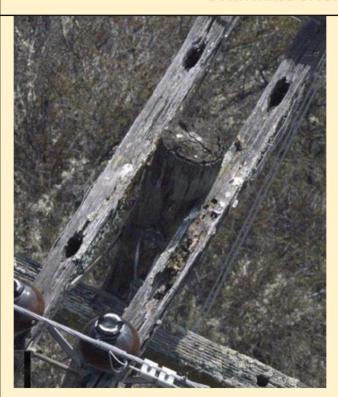
#### Deteriorated Cross-Arm - Aerial View

At this Location: Deteriorated/Rotten Cross-Arm

– Aerial View

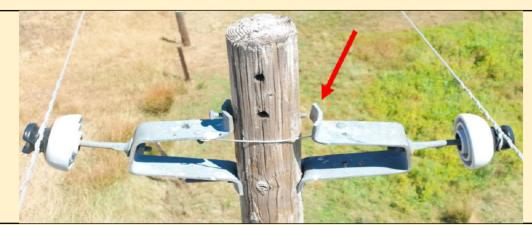
## **Through Bolt Loose**

At this Location: The nut has come off of the Through Bolt

**Priority =** A Tag Emergency

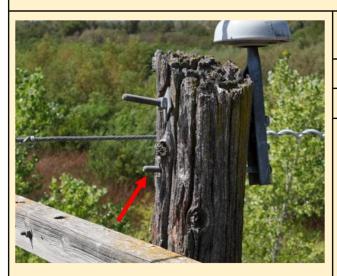
## Missing Hardware – Aerial View

At this Location: The nut on the through bolt has come off of the king pin.

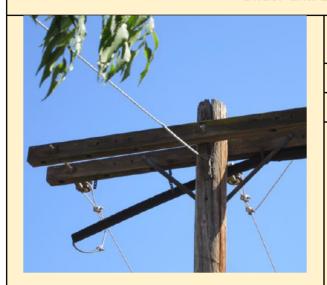
#### **Under-arm Bus Loose**

At this Location: UAB Loose, unattached and hanging

**FDA=** Under-Arm Bus / Broken/Damaged / Repair

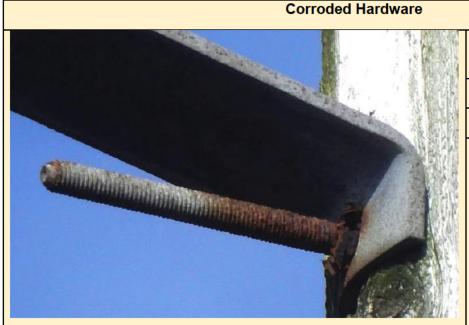
# At this Location: Bolt hardware

extremely corroded

**FDA=** Hardware / Broken / Damaged / Replace

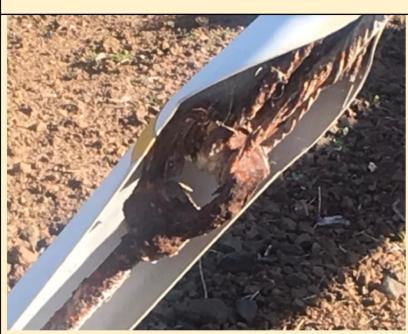
### **Corroded Anchor**

At this Location: Corroded Anchor

FDA= Anchor / Corroded / Replace

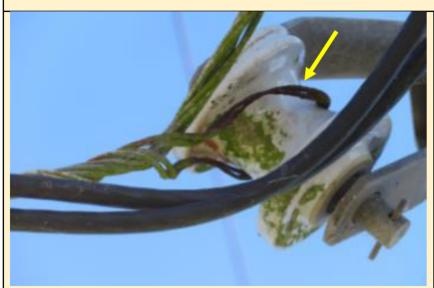
### Corroded Preform Tie

At this Location: Corroded Preform

Tie

FDA= Tie Wire / Corroded / Replace

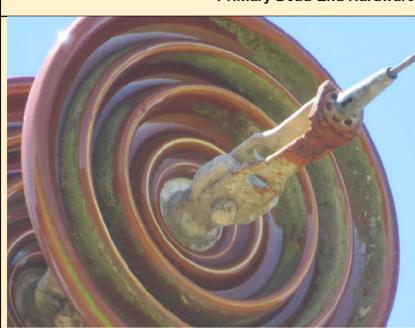
### **Primary Dead-End Hardware Corroded**

At this Location: Primary Dead-End

Hardware Corroded

FDA= Hardware / Broken / Damaged /

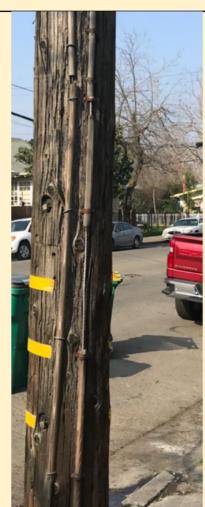
At this Location: Exposed grounds near

sidewalk

FDA=Ground / Exposed / Repair

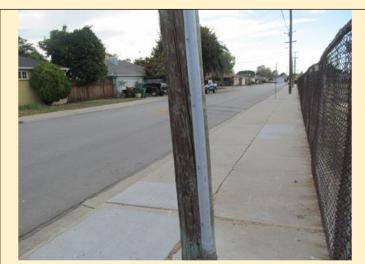
### **REPAIR WITH 1.5" MOLDING**

**Before:** Copper Wire sticking out from under the wood molding

After: 1.5-inch u-shaped molding installed over existing wood molding

At this Location: Wood molding with ground exposed

FDA= Ground / Exposed / Repair

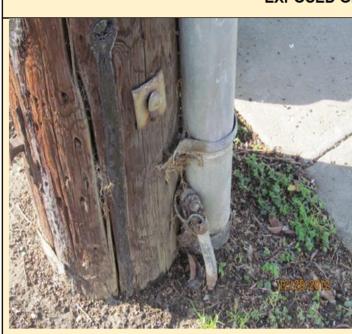
### EXPOSED GROUND ROD

At this Location: Exposed ground rod, public exposure

FDA=Ground / Exposed / Repair

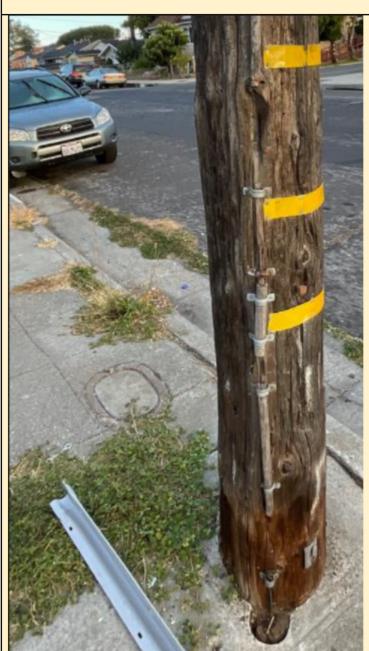
### **Broken Ground Run**

At this Location: Transformer ground has broken, below 8', in the sidewalk, exposed to the public

**Perform Minor Work:** Yes, if safe to do so, Refer to <u>TD-2990P-01</u> for repair.

**FDA=** Ground / Broken / Damaged / Replace or Repair

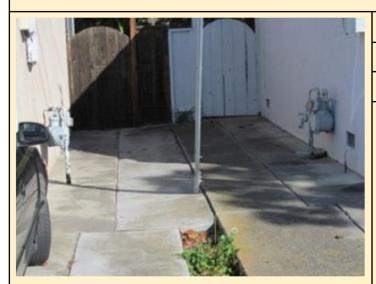
### ANCHOR COVERED BY CONCRETE

At this Location: Anchor covered by concrete

FDA= Anchor /Soil/Eroded/Graded / Replace

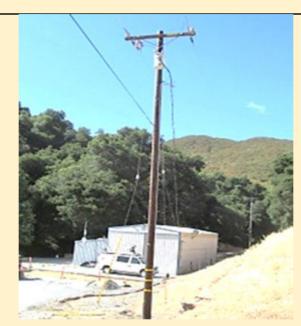
At this Location: Loose guy on left side

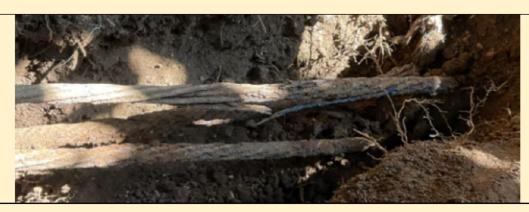
### **GUY CORRODED AND MISSING STRANDS**

At this Location: Guy corroded and missing strands

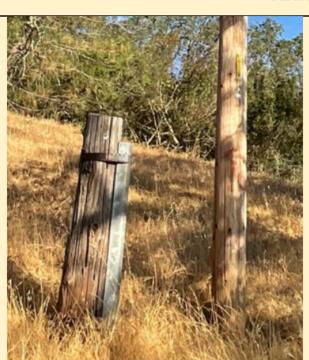
#### **Abandoned Pole Butt**

At this Location: Abandoned Pole Butt, low risk

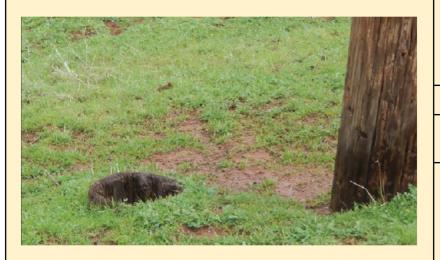
#### Abandoned Pole Butt - Hollowed Out Below Ground Level

At this Location: Abandoned Pole Butt with a safety issue such as a tripping hazard, hollowed out below ground level.

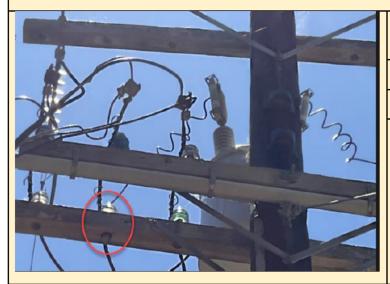
#### Secondary Squatter, Crossarm in good shape

At this Location: Secondary Squatter,

crossarm in good shape

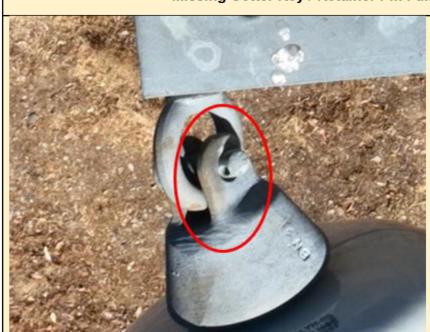
#### Missing Cotter Key / Retainer Pin Fully Seated

At this Location: Missing Cotter Key / Retainer Pin Fully Seated, may fall out

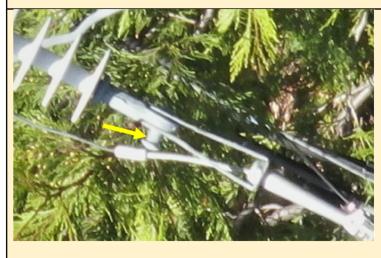
#### Retainer Pin Coming loose, almost pulled out

At this Location: Retainer Pin coming loose, almost pulled out

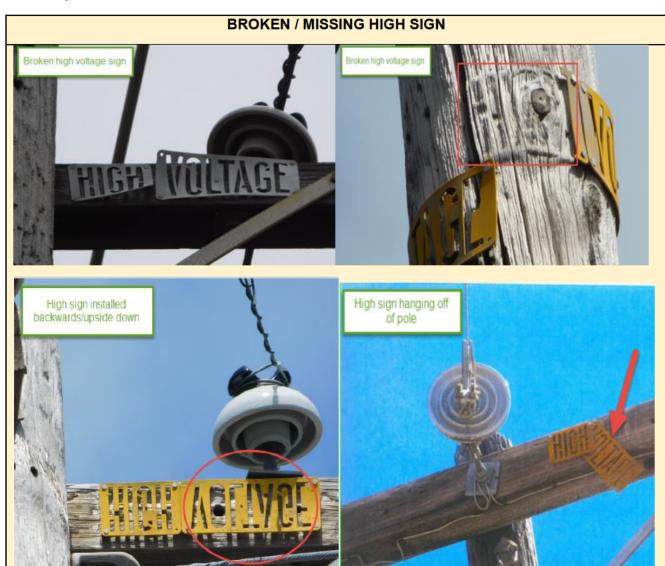
At this Location: Broken / Missing High Sign

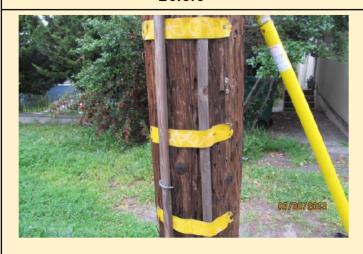
#### Before

At this Location: Metal visibility strips under wood molding and over wood molding with protruding edge.

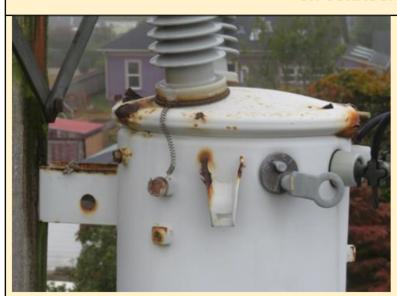
#### **OH CORROSION**

At this Location: Corrosion Weakening Integrity of Tank. Metal is separating into layers. Corrosion will breach tank

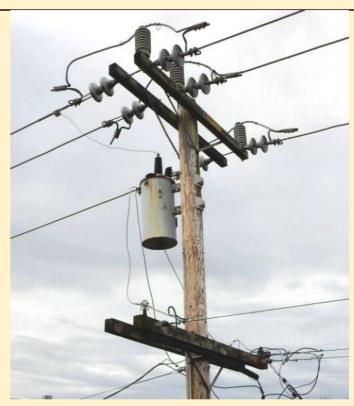
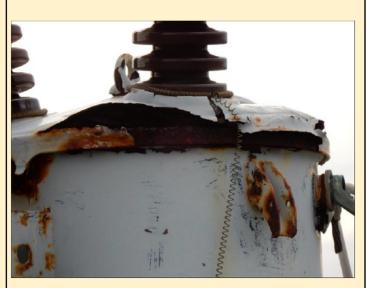
### TRANSFORMER CORROSION

Picture from ground

**Close up Picture**

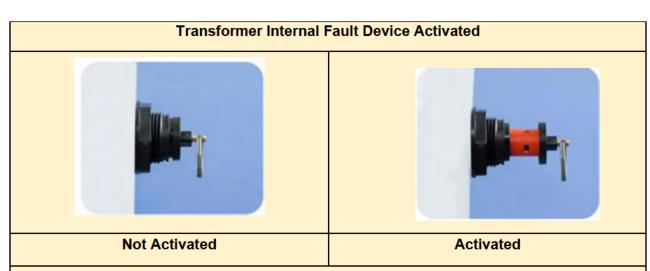
**At this Location:** Transformer internal fault device activated, indicating overheating, and the orange band is visible.

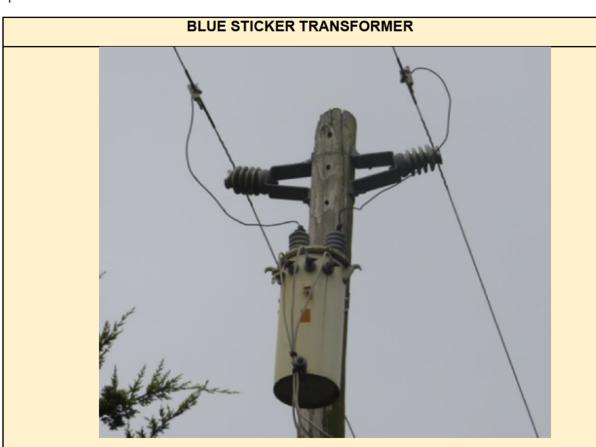
**At this Location:** Blue Sticker not present on transformer, suspect for PCB. Answer questionnaire.

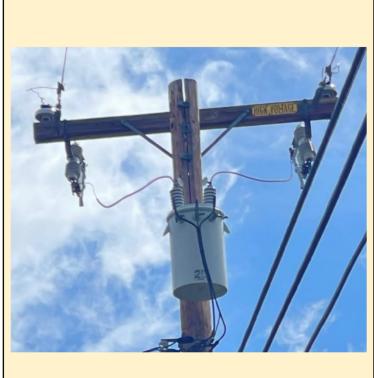
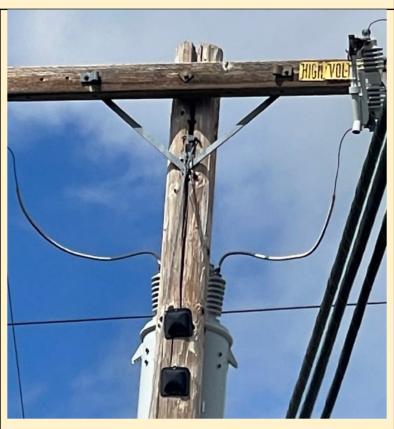
### **POLE SPLIT**

At this Location: Pole top split and can see daylight. Dead end single guy, down guy fixture has moved and slid down from original location onto the brace. Cross-arm brace hardware also compromised. No split bolt.

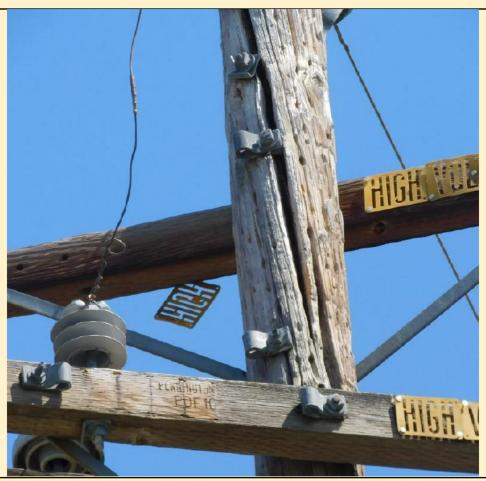
**At this Location:** Checks are opening on the pole at the equipment level. Multiple checks, possible movement on the cross-arm hardware, at the brace bolt on the top cross-arm. Hardware sinking in, pole twist spiral.

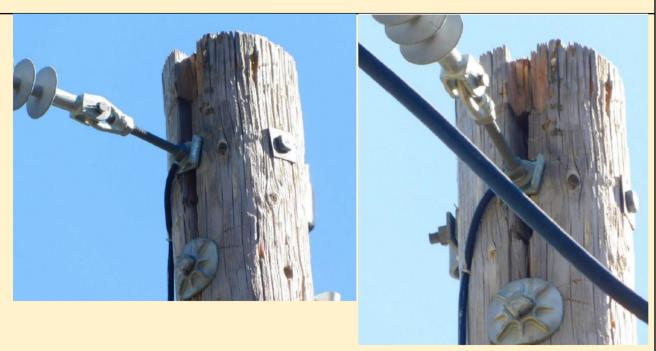
### **POLE SPLIT**

At this Location: Split in the pole top has been corrected with a split bolt, but the dead end has moved and is laying on top of the split bolt.

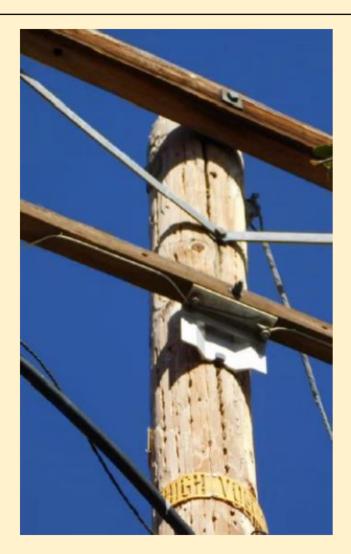
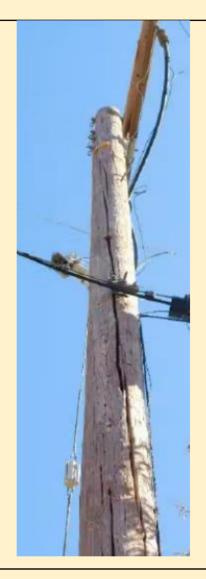
### POLE CHECKS

At this Location: Pole Checks. Down guy acting as split bolt. Multiple vertical cracks running down pole are not at the points of attachment affecting the hardware. No compelling abnormal conditions to report.

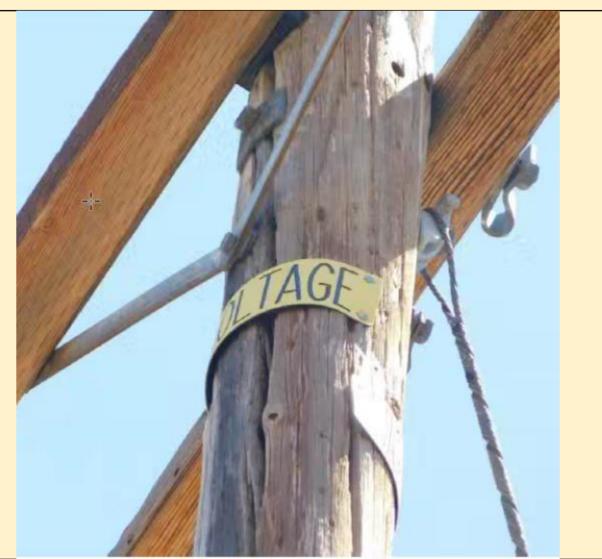
At this Location: Pole checks at the equipment level attachments but not affecting the hardware. Not a compelling abnormal condition, will last another 5 years.

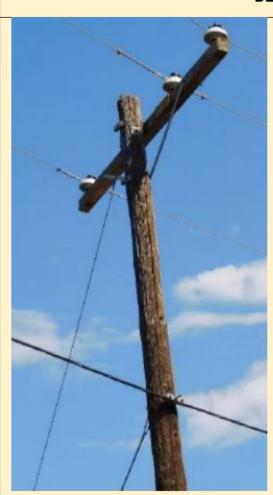
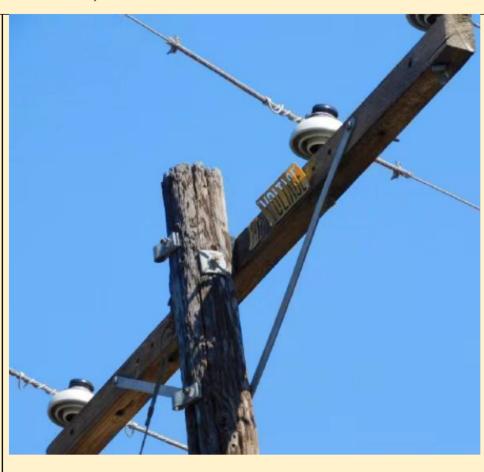
### DECAYED POLE, MULTIPLE ISSUES

At this Location: Pole has multiple conditions: Pole in poor condition, decayed, and extensive weathering, and pole top rot. Pole checks alone are not a compelling abnormal condition, but in combination with all the other conditions, write EC tag.

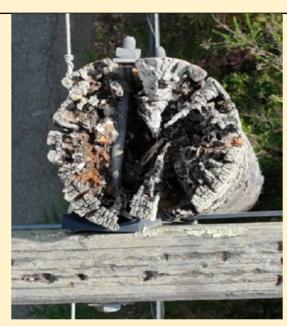
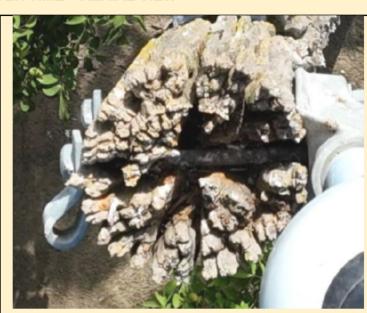
### DECAY OF POLE OVER TIME - AERIAL VIEW

At this Location: Pole top decayed. Complete the Pole Inspection Test Report

Perform Minor Work: No	Perform Minor Work: No
Write 3 <sup>rd</sup> Party Notification: No	Write 3 <sup>rd</sup> Party Notification: No
Write EC Notification: Yes	Write EC Notification: Yes
FDA= Pole Decayed/Rotten/Replace	FDA= Pole Decayed/Rotten/Replace
Priority= A Tag, Follow emergency Procedure	Priority= B Tag, 0-3 Months depending on exposure

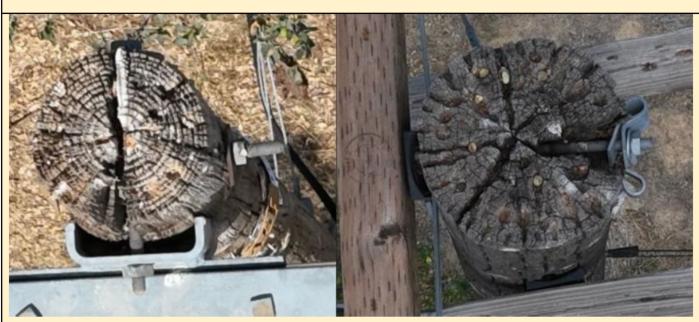
### **DECAY OF POLE OVER TIME – AERIAL VIEW**

At this Location: Pole top decayed. Complete the Pole Inspection Test Report

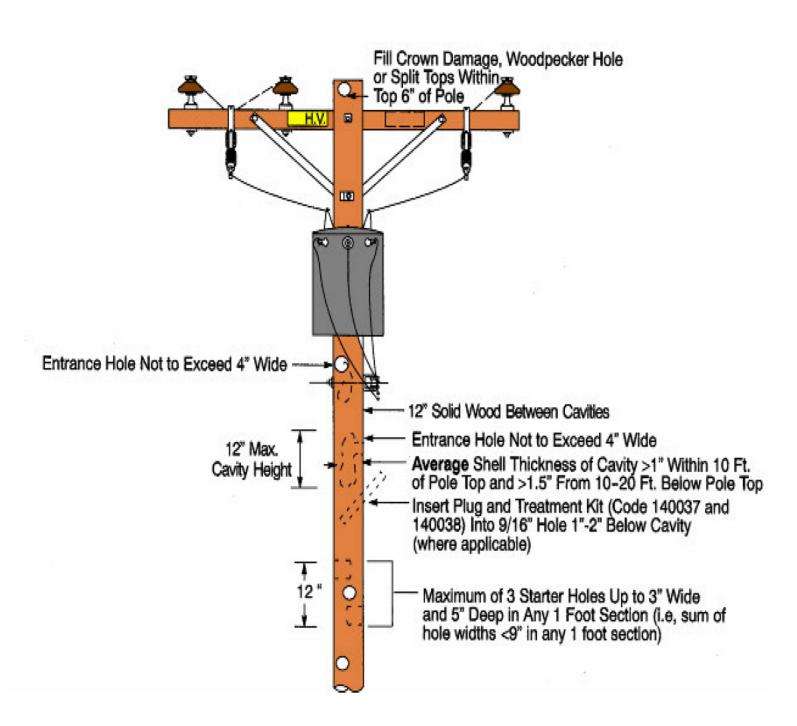
Repair of Woodpecker-Damaged Pole Tops

Determine whether identified above-ground or pole-top damage is suitable for restoration. Poles are suitable for restoration and can remain in service if they meet the criteria listed below and are repaired by a construction crew with the epoxy method per 066209:

- The pole-top crown damage or split tops extend downward less than 6 inches from the pole top.

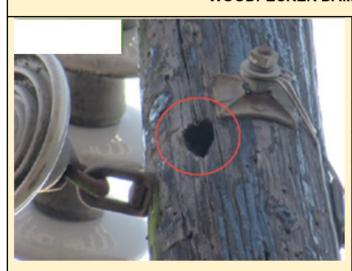
#### WOODPECKER DAMAGE MEDIUM CAVITY

At this Location: Woodpecker holes near framing hardware, per Guidance "There is 1 vertical inch of solid wood directly below any through bolt to support existing or proposed attachments".

FDA= Pole / Woodpecker Damage / Replace

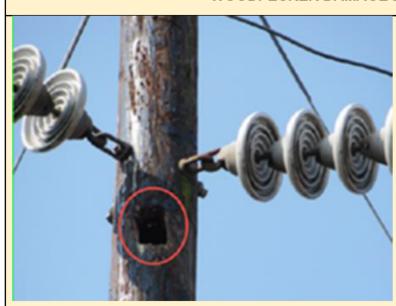
#### WOODPECKER DAMAGE LARGE CAVITY

At this Location: Comparing to the insulators Woodpecker holes appear to be close to 7" per Guideline "Nesting cavities or other open pockets have an outside hole diameter that is less than 4 inches wide.".

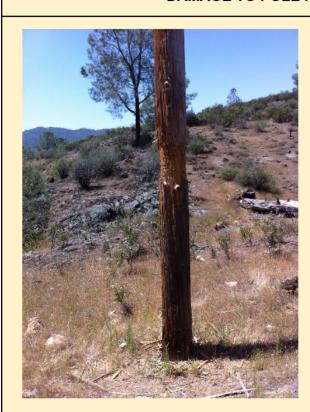
#### DAMAGE TO POLE FROM SPECIFIC EVENT

Pole has reduced circumference, write EC notification for estimating to confirm pole loading.

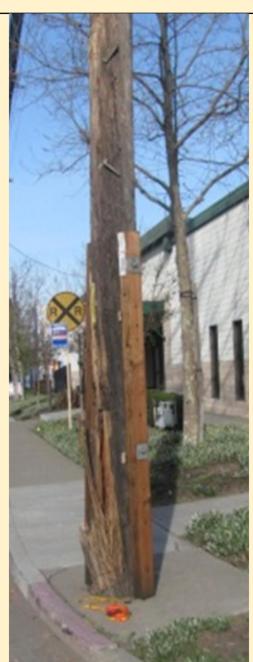
### VEHICLE DAMAGE, TEMP REPAIRS MADE

At this Location: Pole damaged by vehicle. Cross-arm acting as Splint installed as temporary repair

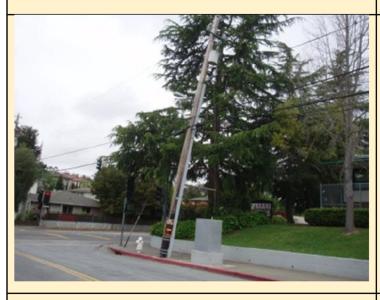
### STUBBED POLE LEANING TOWARDS SCHOOL

At this Location: Stubbed pole leaning towards school, supported by down guy. Pole Bands are loose due to additional deterioration of the pole.

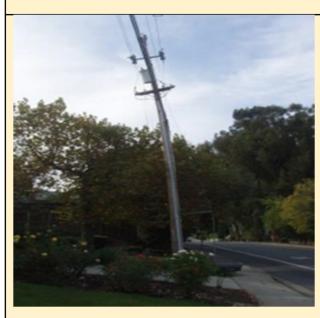
**At this Location:** Pole bent 4 feet out of line, less than 10% lean, deformed in the middle of the pole, towards vegetation

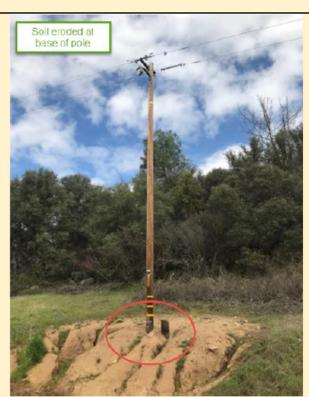
### Soil eroded at base of pole

At this Location: a large amount of soil was washed or eroded away at the base of a pole, Not leaning.

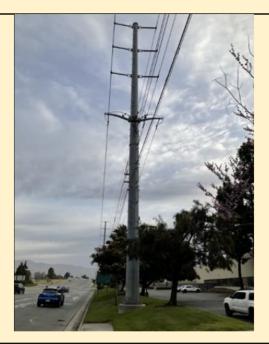
### Steel Transmission Structure with Distribution Underbuild with internal riser within steel pole

At this Location: Steel Transmission Structure with Distribution underbuild with internal riser within steel pole

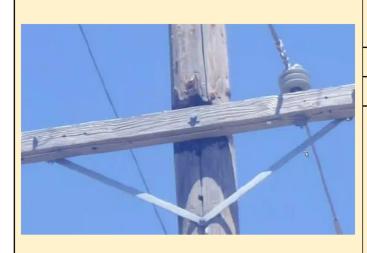
### BURNT POLE DUE TO MISSING BRIDGING

At this Location: Transmission pole with missing bridging on the distribution cross-arm, burnt pole, assess pole

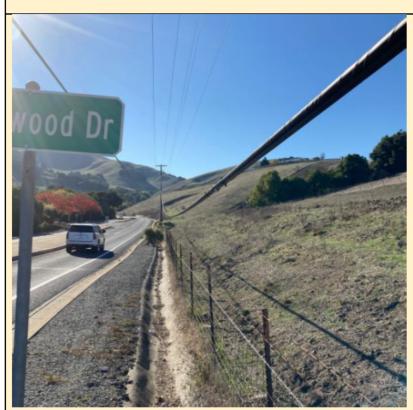
### **Communication Line Extremely Sagged**

At this Location: Comm sag 6' above the road, off the road, no potential for vehicle contact.

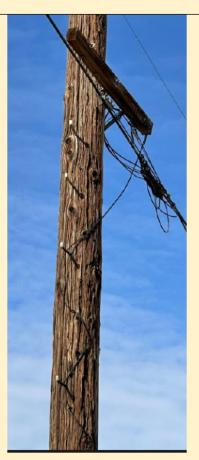
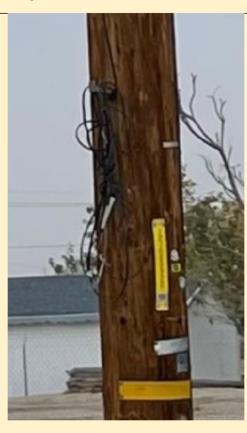
# Abandoned Phone Drop

At this Location: Abandoned Phone Drop

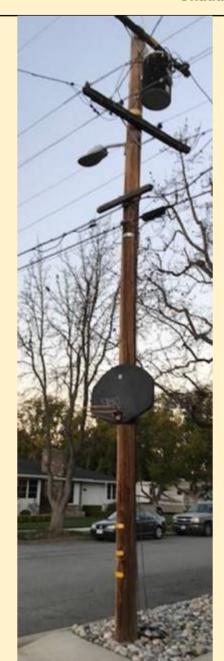
### **Unauthorized Attachment**

**At this Location:** Basketball Hoop Installed on a PG&E pole.

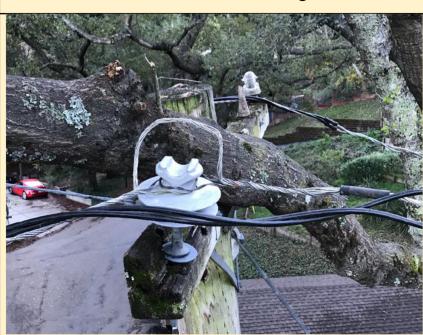
### Large Branch Broken

At this Location: Large branch broken on cross-arm. Cross-arm in poor condition, immediate response required.

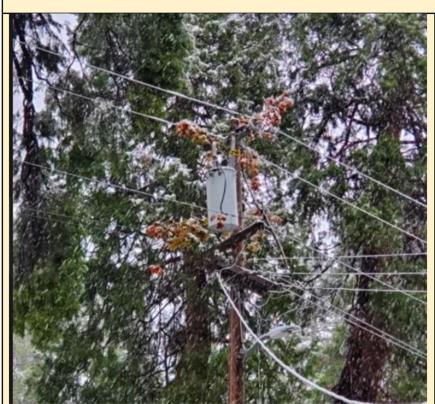
### **Dead Tree Branch fell into Primary**

At this Location: Dead tree branch

fell into primary

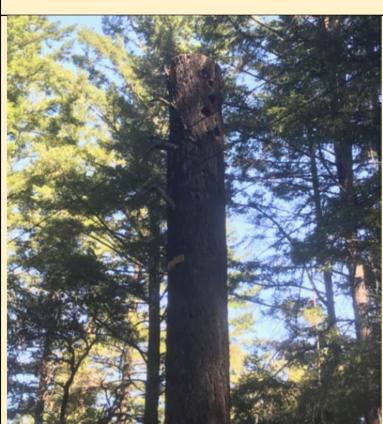
### TREE CONNECT ON DEAD/DYING TREE

At this Location: Tier 2 area, tree connect on dead/dying tree with multiple woodpecker holes and damaged primary insulators

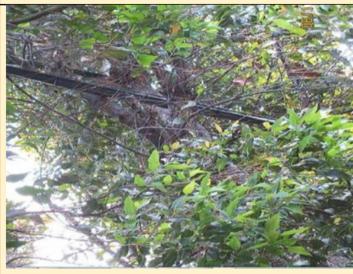
# PHONE TREE CONDITION

At this Location: Tree putting strain on the pole, due to communication line

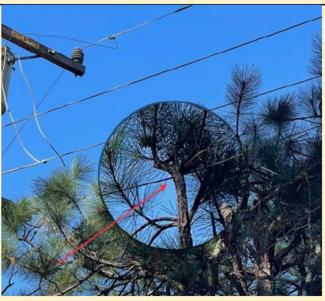
# SECONDARY OVERGROWN REDUCING CONDUCTOR CLEARANCES

At this Location: Secondary conductor resting on tree/vegetation. Tree causing strain on open wire secondary, feeding more than one customer.

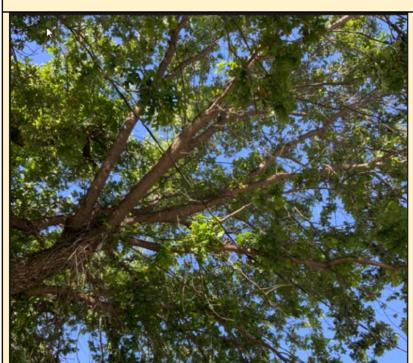
### Tree Strain on Service Drop

At this Location: Tree strain on service

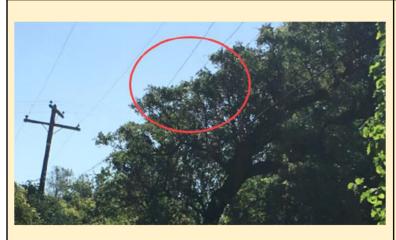
# TREE GROWING INTO BARE OPEN WIRE SECONDARY OR BARE OPEN WIRE SERVICE, NO STRAIN OR ABRASION

**At this Location:** Tree grown around bare open wire secondary, no strain or abrasion. Spreader bracket already installed.

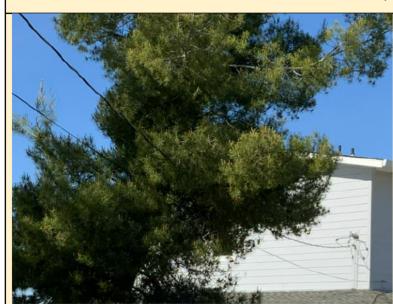
### TREE GROWING AROUND SERVICE, NO STRAIN OR ABRASION

At this Location: Tree grown around service, no strain or abrasion.

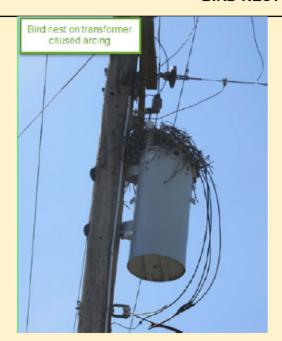
#### **BIRD NEST ON TRANSFORMER**

At this Location: Bird Nest on transformer, abandoned, touching high side jumper.

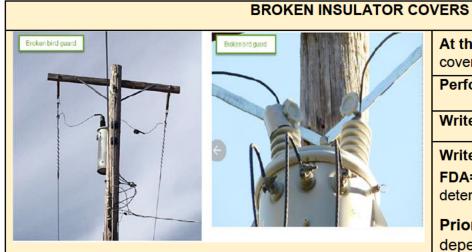
### At this Location: Broken insulator

covers

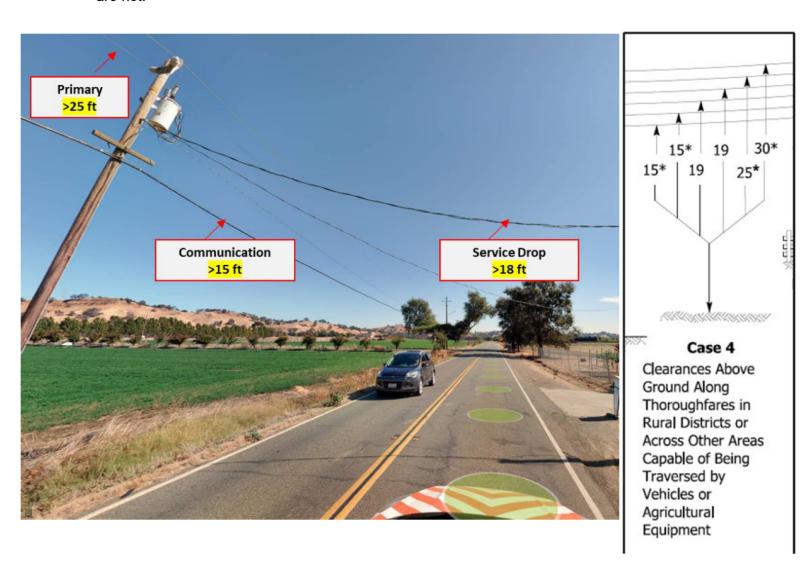
### Case 4: Along or Crossing a Rural Road

**NOTE:** Due to the fisheye lens and the online street view, the poles appear to be leaning but are not.

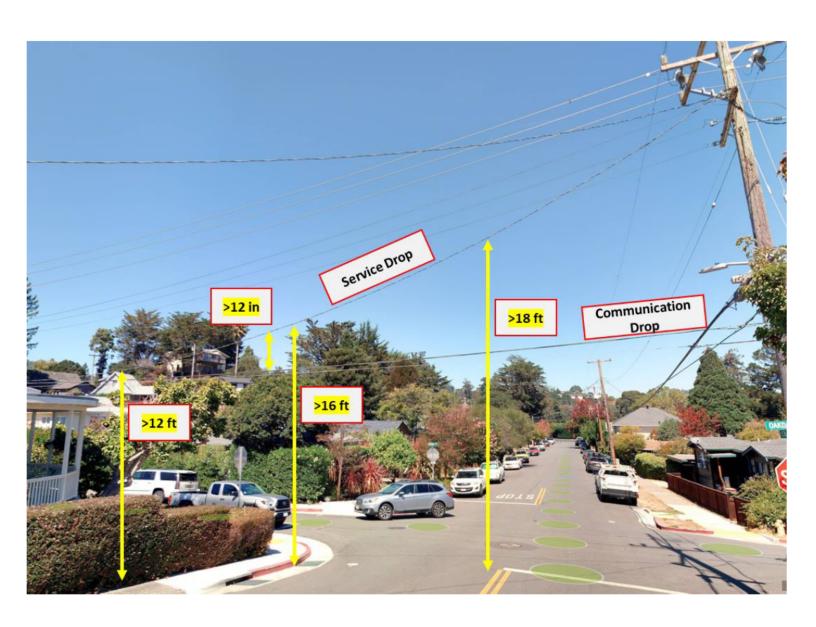
Service Drop - Residential

**NOTE:** Due to the fisheye lens and the online street view, the poles appear to be leaning but are not.

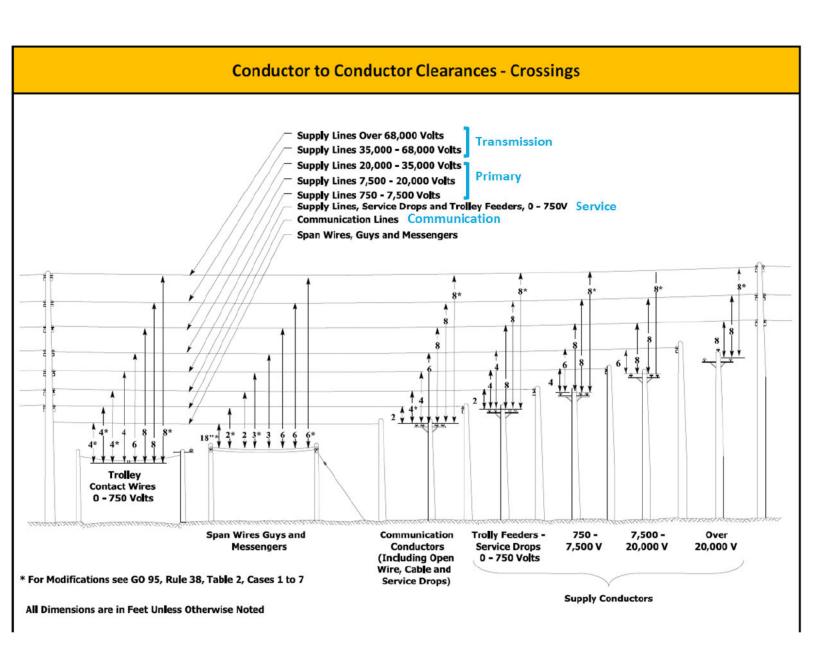
Conductor to Conductor Clearance on Crossing Poles

300kV plus transmission circuits require 156 inches of clearance to the primary.

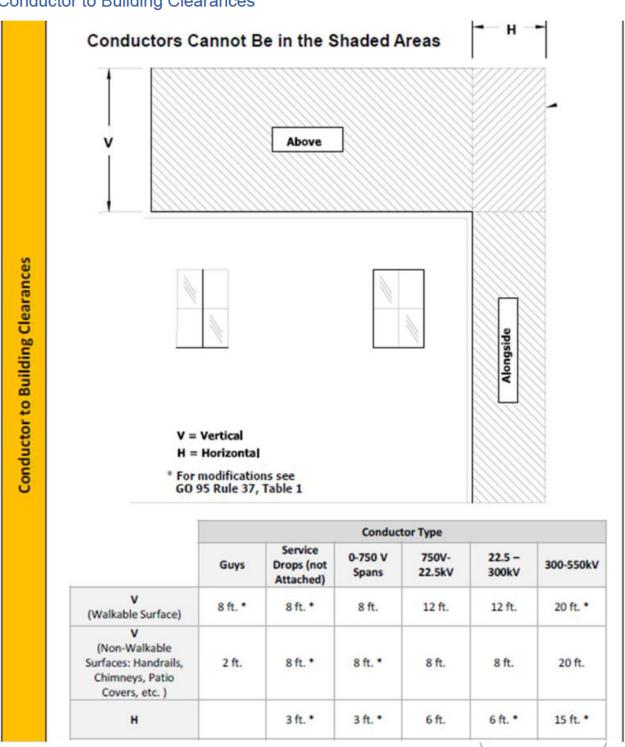
### Conductor to Building Clearances

Service Secondary Primary Transmission

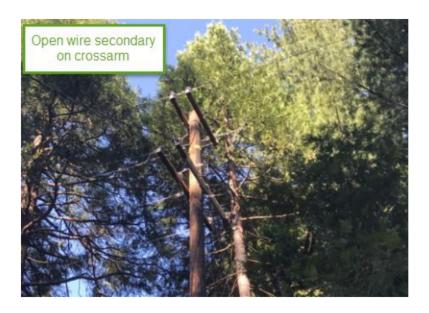
### Open Wire Secondary

Field condition of open wire secondary built on a cross-arm

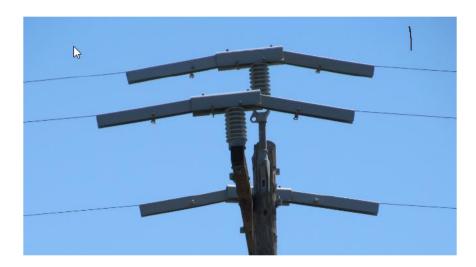
### Bird protection

Center phase cover installed on conductor

General Guidance: Evaluate locations where bird protection has previously been installed to assess if it is adequate or is missing or broken. If not adequate or needs repair, create EC notification to repair or install.

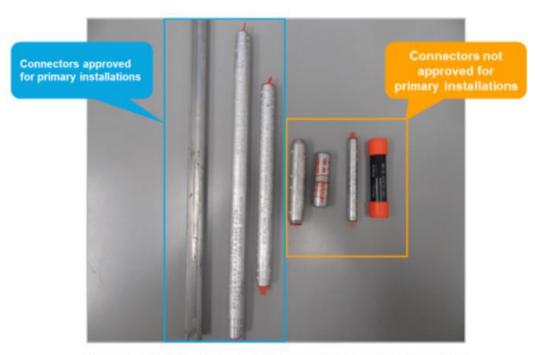
### Connectors / Splices

Example slide 132: Approved and Unapproved connectors for primary

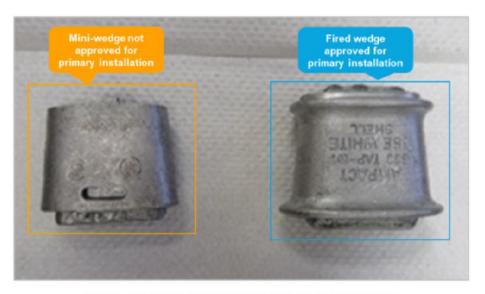
### Wedge Connectors

Example slide 132: Approved and Unapproved connectors for primary.

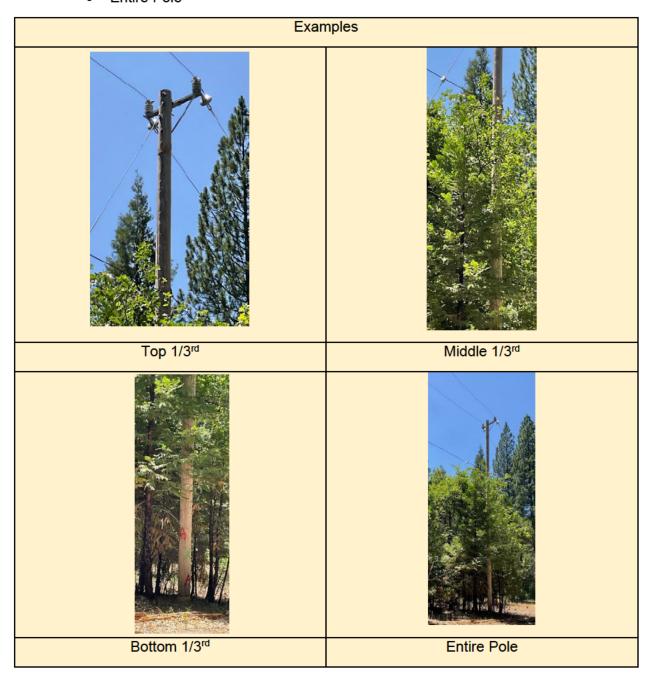
#### 1. Pole

- Top 1/3<sup>rd</sup>
- Middle 1/3<sup>rd</sup>
- Bottom 1/3<sup>rd</sup>
- Entire Pole

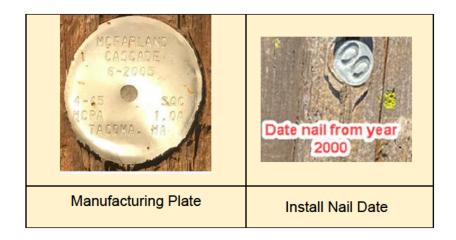
### 2. Pole Age

- Manufacture plate
- Install nail

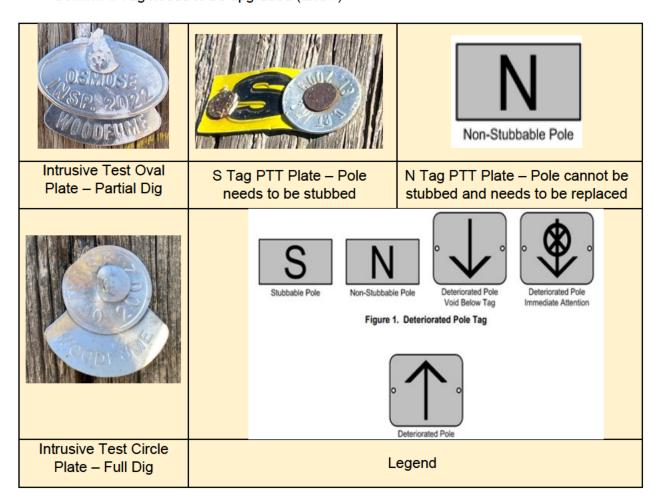
#### 3. PTT Records (if available)

- Most recent Intrusive Test year
- Confirm no "S" Stubbable Pole or "N" Non-Stubbable Pole
- Confirm if Tag needs to be upgraded (arrow)

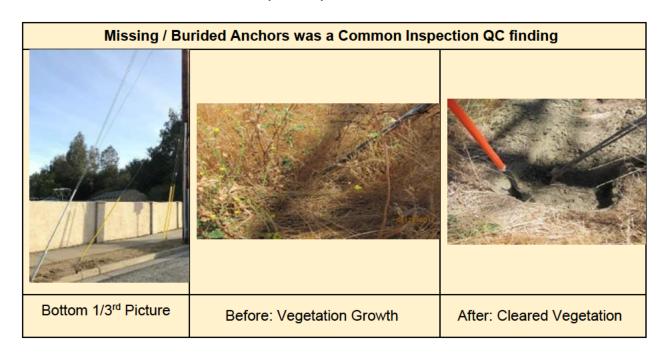
#### 4. Anchor

- Close up Unobstructed View of anchor(s)
- May need to unearth anchor, if possible
- · If anchor is buried, still provide picture
