Pacific Gas and Electric Company Securitization

Letter from PG&E's Federal Monitor Dated 10-16-20

Re: Information Request Regarding Monitor Team Field Inspections

**PG&E Monitor Team Immediate Hazard
Reported October 4, 2020**

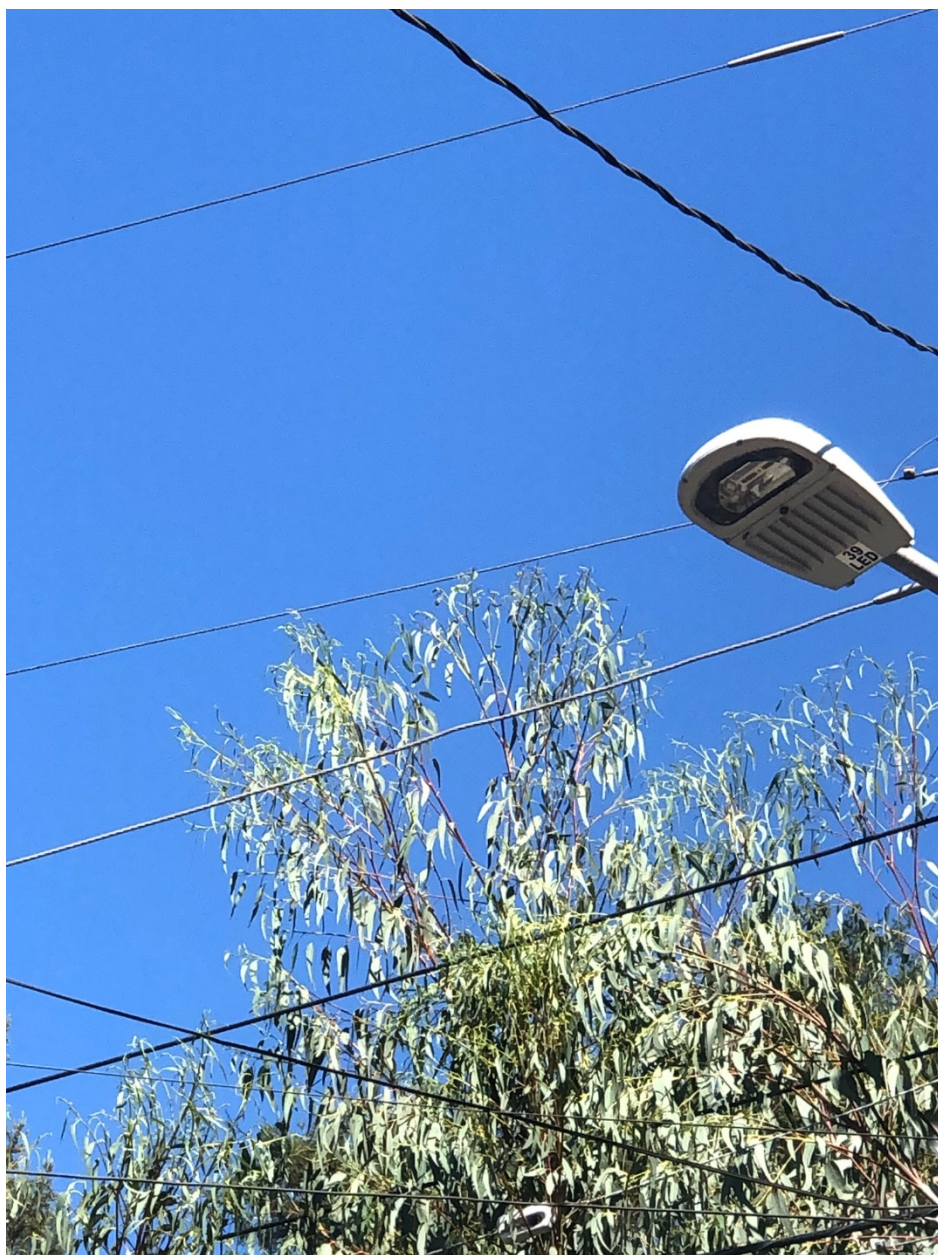
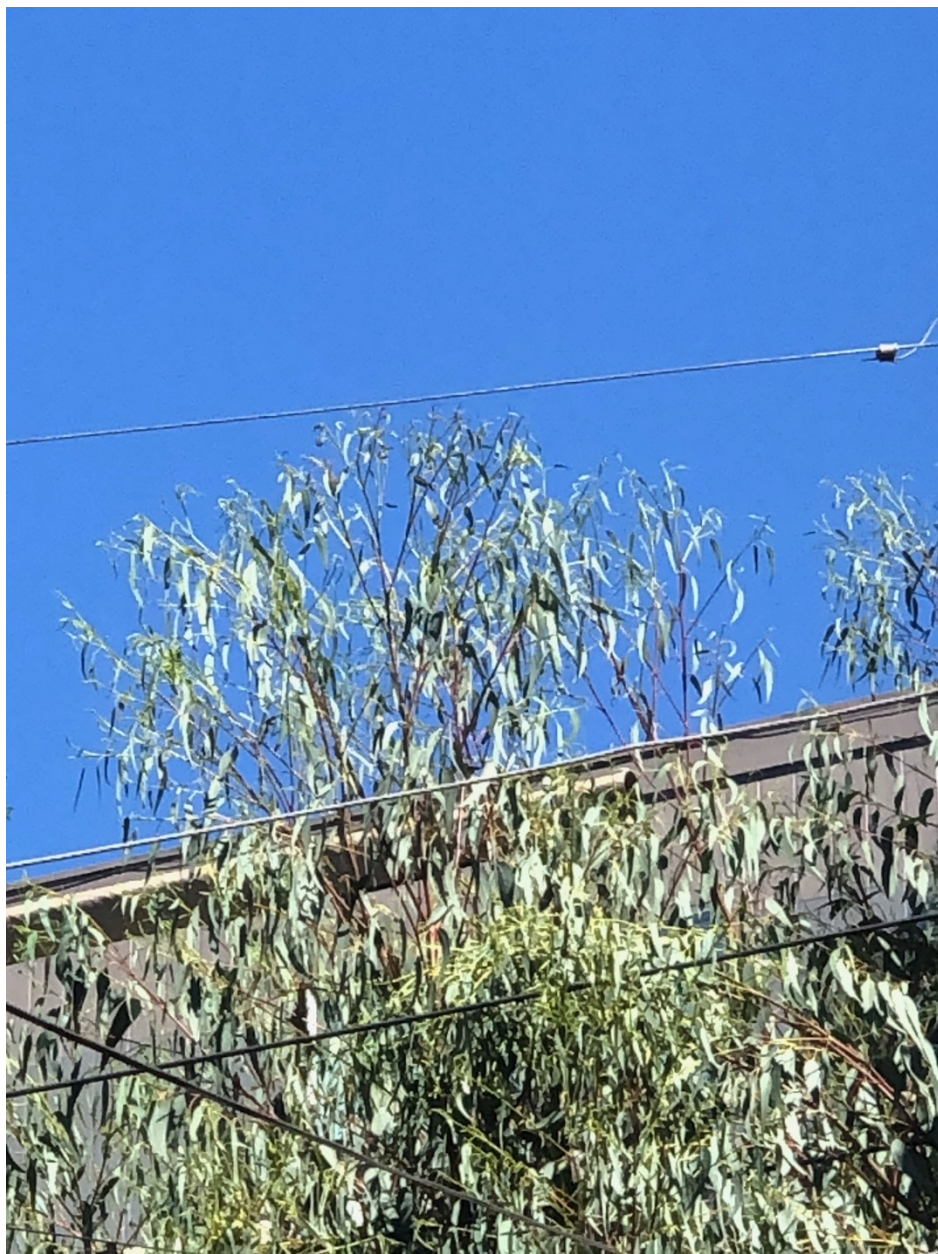
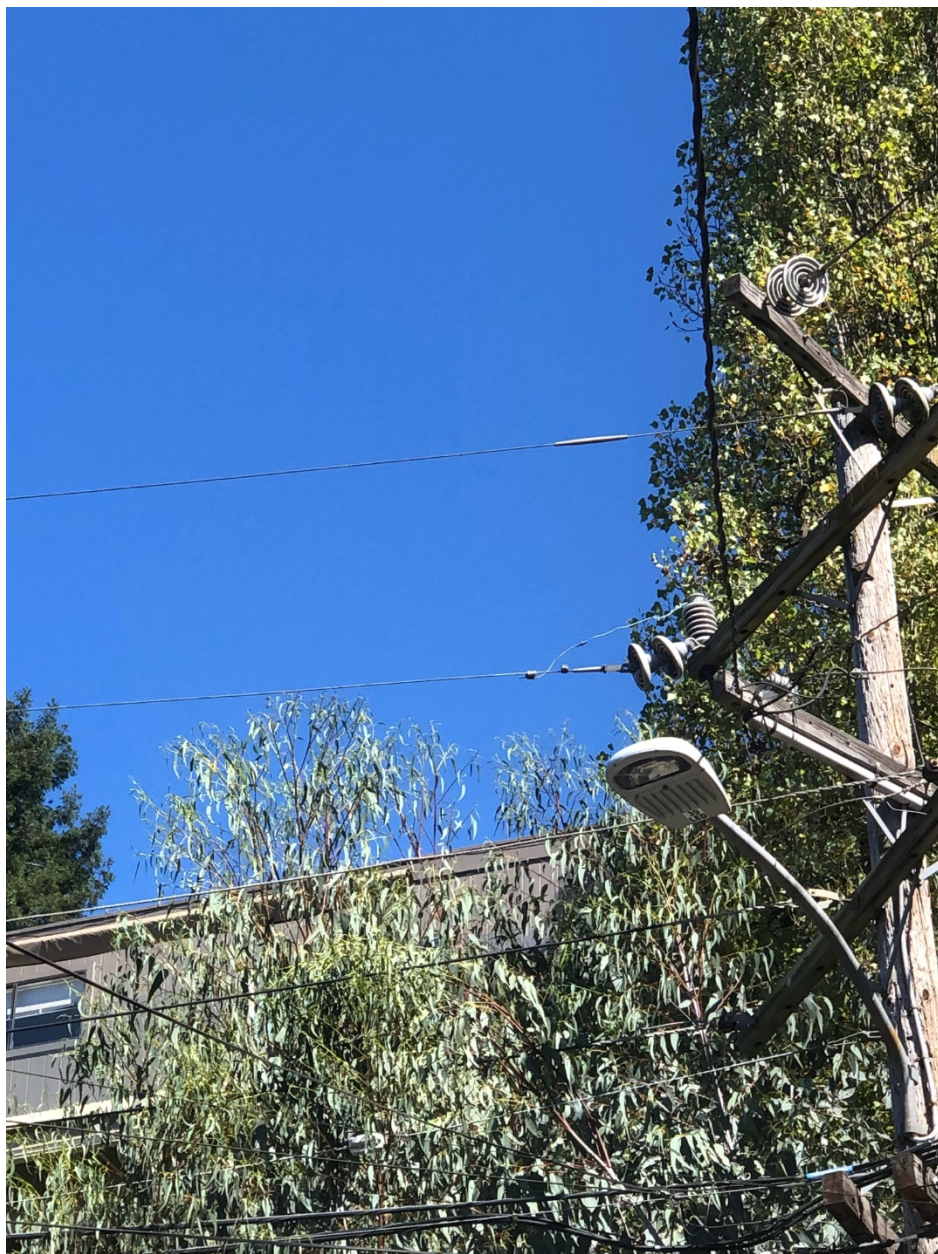
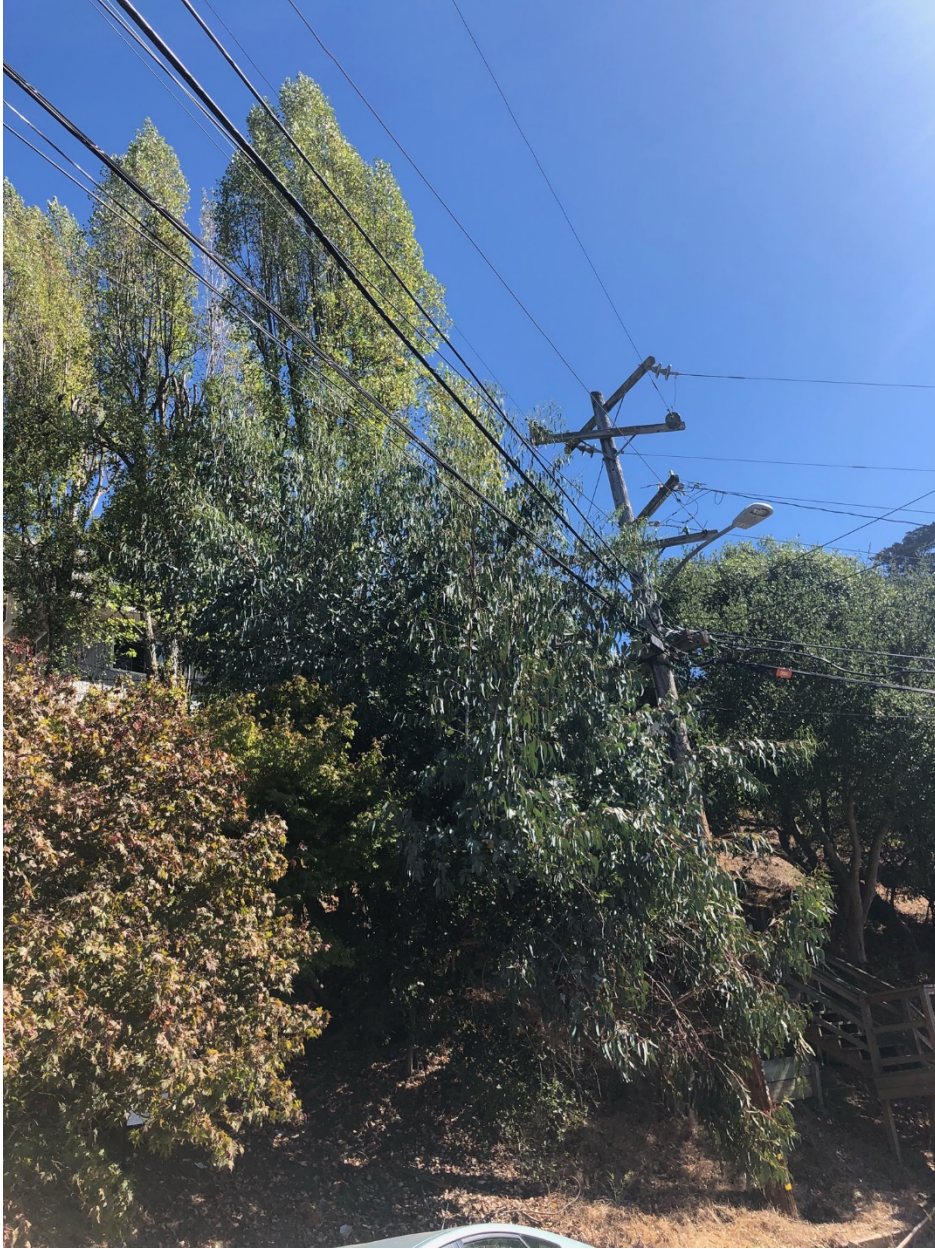
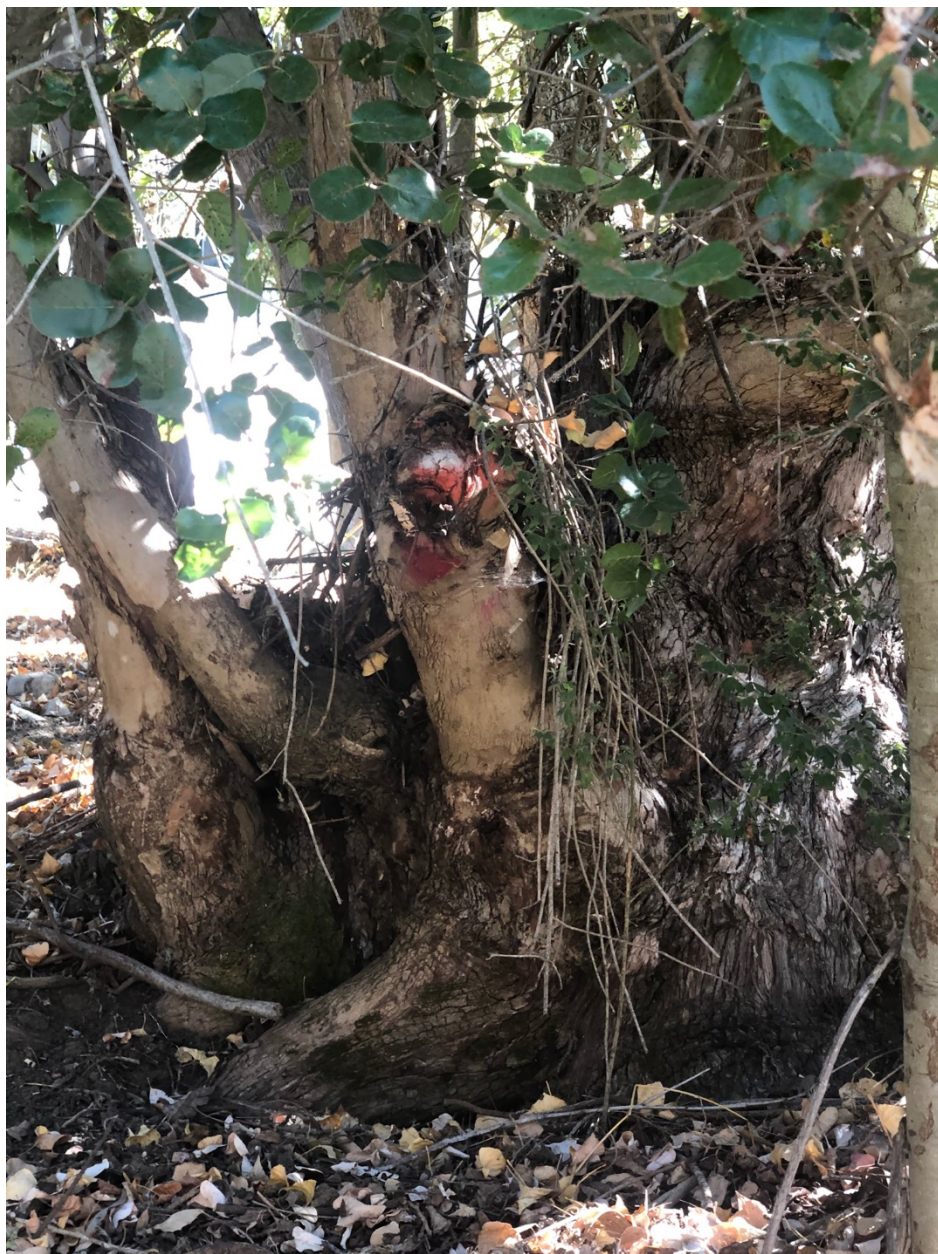
On a per-mile basis, the Monitor team is finding more missed trees (what we refer to as "potential exceptions" to the EVM scope) in 2020 than we did in the later part of 2019. For perspective, from May to July 2019, the Monitor team found 11.4 potential exceptions per mile. After we discussed the underlying deficiencies with PG&E throughout the summer and early fall of 2019, and following revamped training by PG&E, the quality of work improved, and the exception rate dropped to 1.1 potential exceptions per mile from September to December 2019. This year, the Monitor team has found approximately 4.82 potential exceptions per mile, with potential missed hazard trees accounting for roughly half of the exceptions. Therefore, although there were meaningful improvements within 2019, that improvement appears to have, at best, plateaued, and perhaps actual regression has occurred. For the Court's reference, we have attached a finding from an October 4, 2020 inspection, during which we identified a tree that PG&E was supposed to have removed in mid-August, but twice failed to remove, seemingly because of a series of process breakdowns. The leaves on the tree had singed from contact with the conductor.

- Segment ID: CIL_AO123-K17_233536
- GPS Coordinates: 37.8359150, -122.2016603
- Nearby Address: 6924 Snake Road, Oakland, CA 94611
- Veg Point ID: VP_AO123-K18_1733229_2020
- HFTD: Tier 3
- Species: Blue Gum / Eucalyptus
- Height: 38
- DBH: 54 (including multiple stems)
- Monitor Team Observations: Leading sprouts of tree observed within one inch of primary conductor, and tree shows evidence of singeing from prior contact with conductor. Tree also located on steep slope with exposed roots.
- PI Comments field in Arc Collector states: "L/O PI 0907 Uphill Multistem, sent to HN URG 8/12/2020 M8D9 - revisited 8/31/2020, HN not complete, created WI point for removal M8D9"
- Photos of the potential exception are included below.

Following the Monitor team's identification of the tree and immediate escalation to PG&E management, PG&E removed the tree within 24 hours.
