Prepared for:
Pacific Gas & Electric Company

Investigation Of The AC2 Air Conditioner

Final Report, December 30, 1998

Prepared by:
Proctor Engineering Group

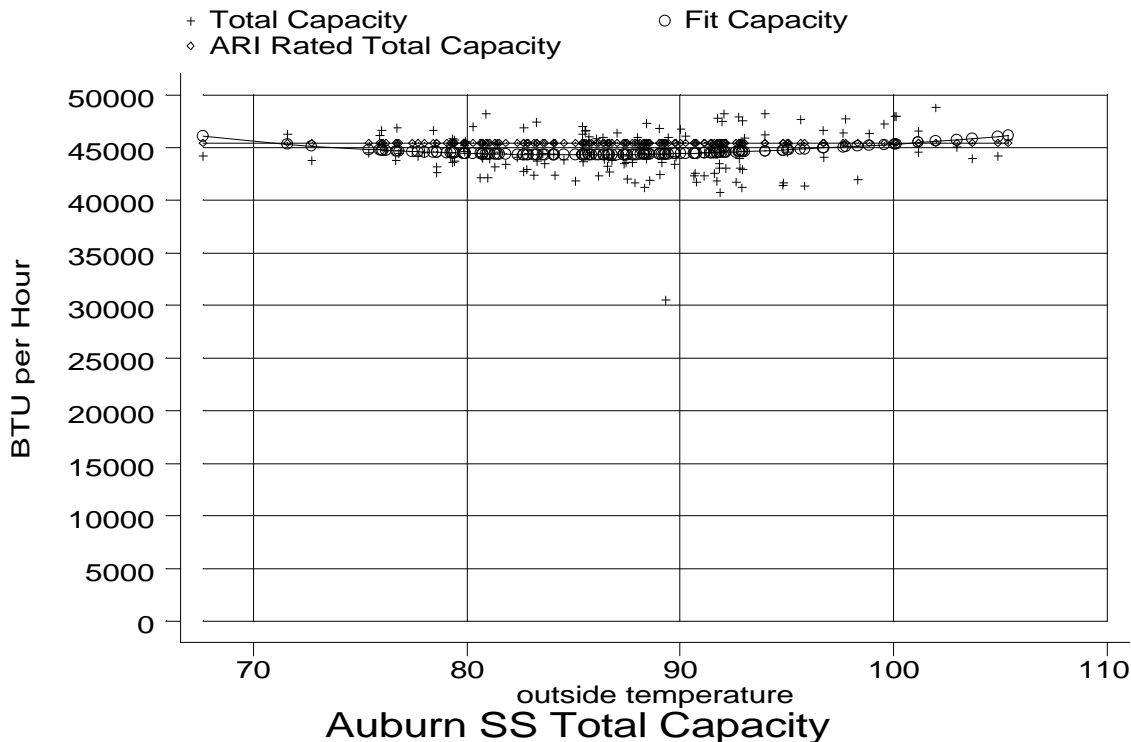
Figure 4-1. Steady State Total Capacity -- Auburn

The first area of interest from the monitored data is the total capacity of the AC2 units. The total capacities of four of the five units are within 4% of the manufacturer's published data. These units have capacities within measurement error of manufacturer's data. The steady state total capacity for one unit is shown in Figure 4-1.

Unlike typical air cooled condenser air conditioners, these units are relatively unaffected by the outside dry-bulb temperature.

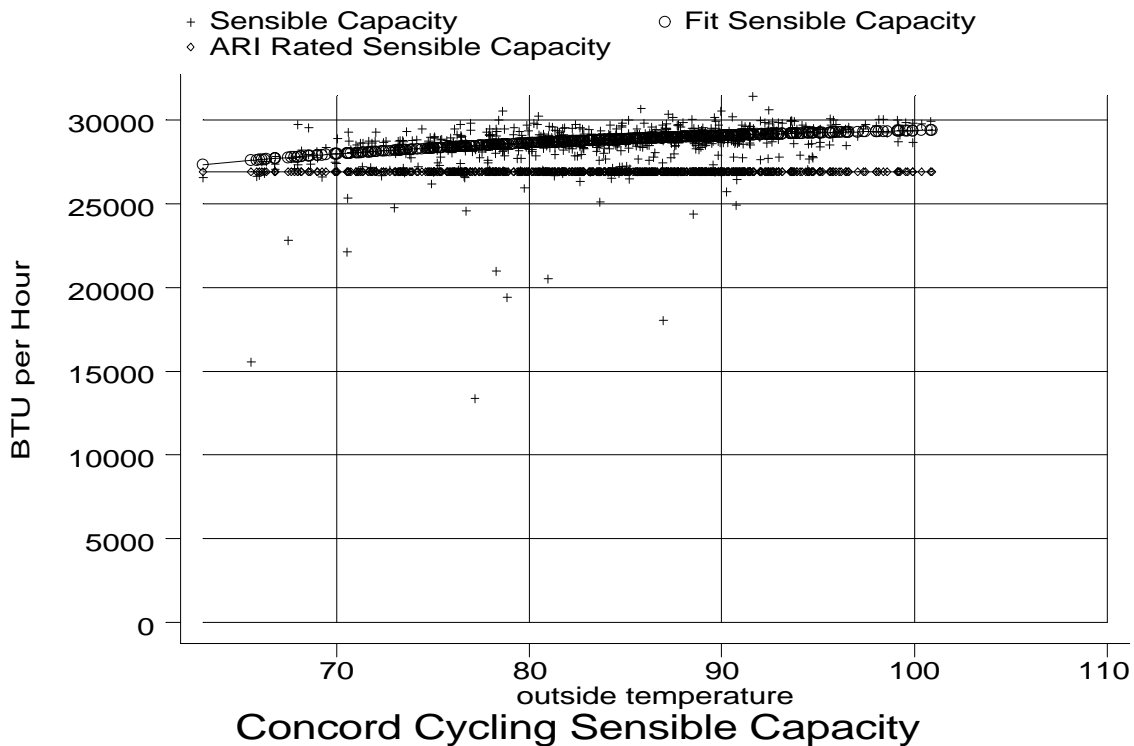
Figure 4-2. Cycling Sensible Capacity -- Concord

The Cycling Sensible Capacities on these units exceed the manufacturer's test data for steady state operation because they are operating at return humidities lower than ARI conditions. Low return humidity raises the sensible capacity. The Cycling Sensible Capacity of one unit is shown in Figure 4-2.

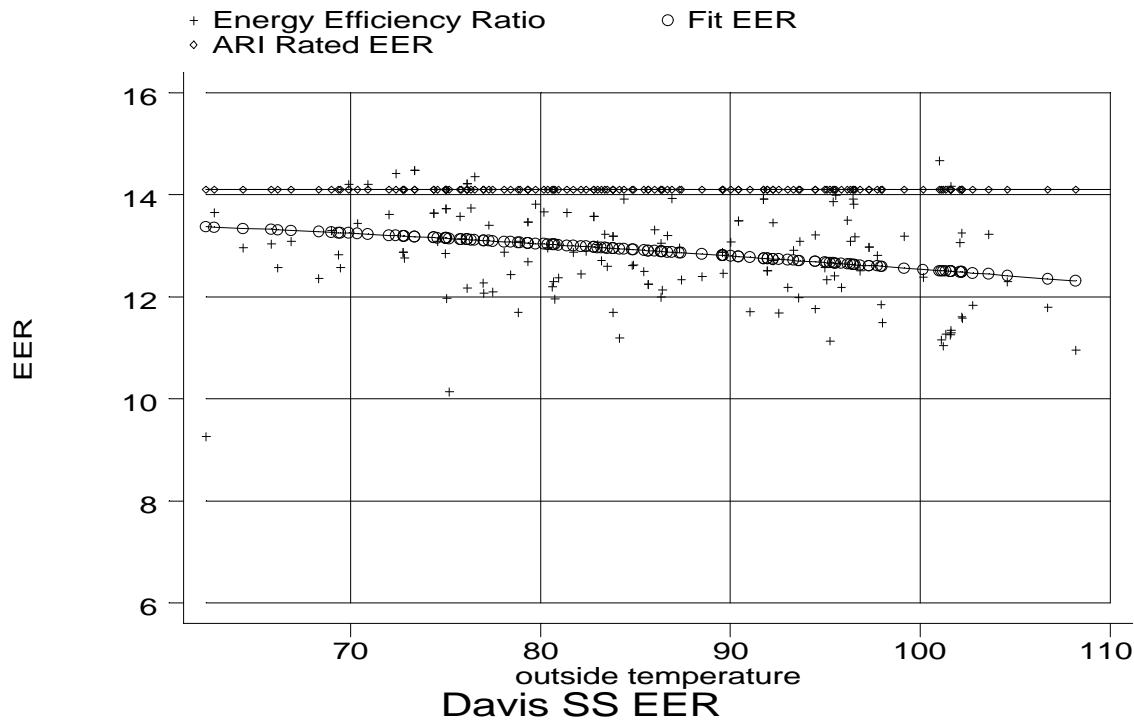
Figure 4-3. Steady State EER -- Davis

The four properly performing units had steady state total capacities equal to the manufacturer's ARI results. Nevertheless, the average steady state EERs for these units average only 88% of the ARI results. The watt draws of these units exceed those reported by the manufacturer. This decrement in steady state EER for one unit is displayed in Figure 4-3. .

The excess watt draws on these units are artifacts of the DOE/ARI test procedure that substantially underestimates the watt draw of the air handler. The DOE/ARI assumptions and measured values are shown in Table 4-1.

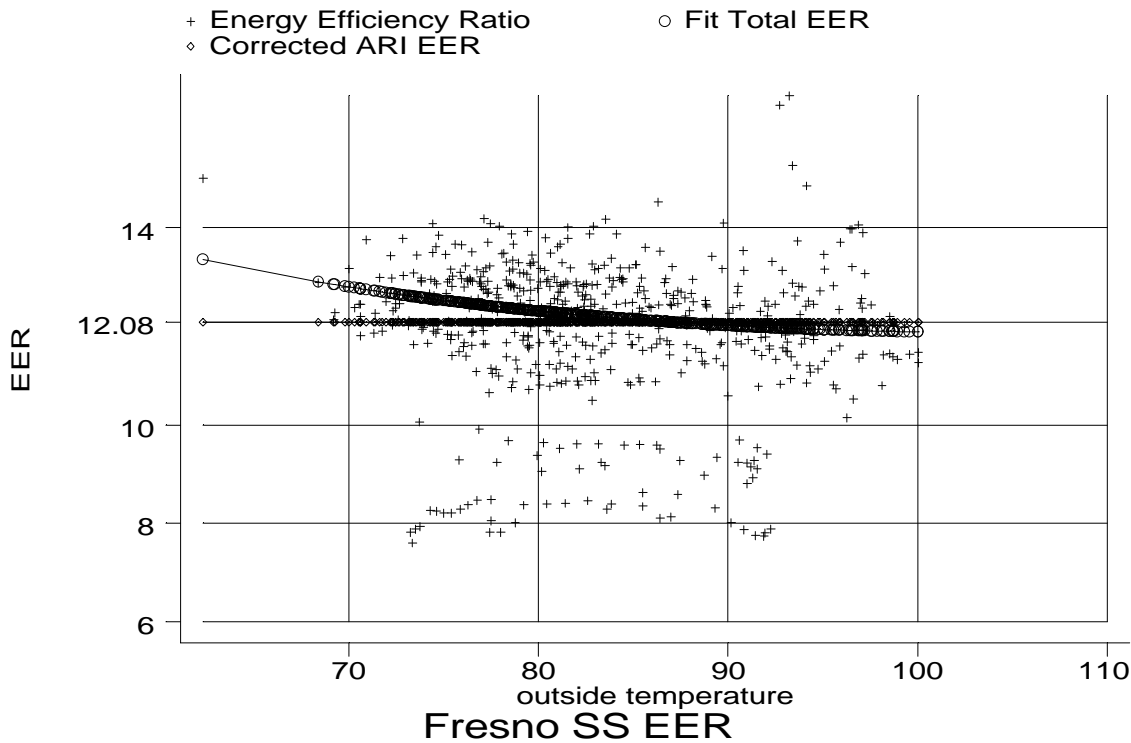
Figure 4-4. Measured Steady State EER vs. Corrected ARI EER -- Fresno

When the manufacturer’s data for the four properly performing units have the DOE assumed fan motor values replaced by the actual values, the average steady state EER and the corrected ARI results agree (Field data average 97% of the corrected ARI results). In Figure 4-4, the steady state EER for one unit is compared to the corrected ARI EER.

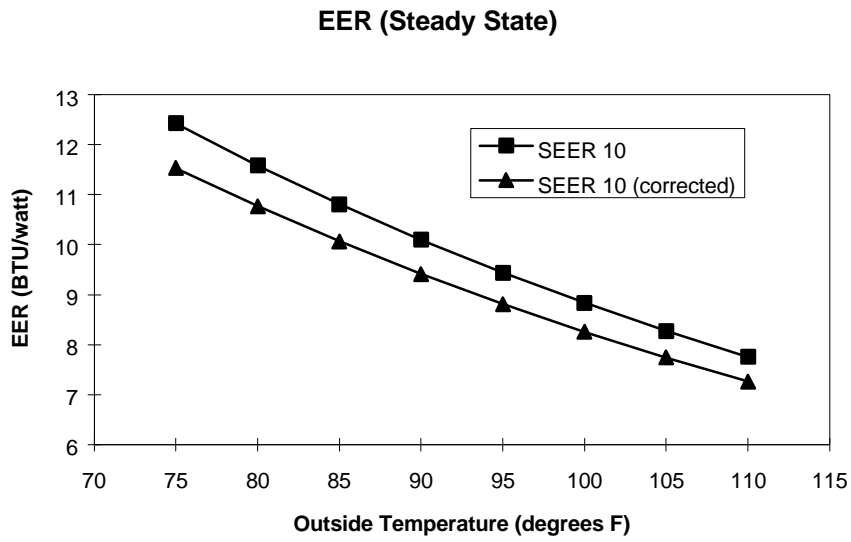
Figure 4-5. Published EER vs. Corrected EER -- Typical SEER 10 Unit

Standard air cooled condenser units also have EERs exaggerated by the test procedure. When the manufacturer’s data are corrected to the true watt draws of the fans, the EERs are close to those found in monitored data. (Blasnik et al., 1996)

Figure 4-5 compares the published EERs (using the DOE assumed fan energy) to the corrected EERs.

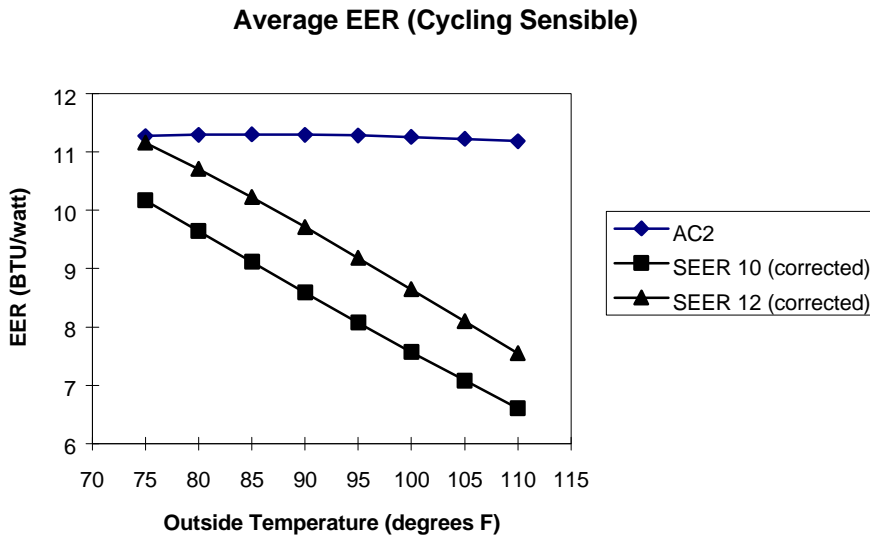
Figure 4-6. Cycling Sensible EER -- AC2 Units vs. Typical SEER 10 and SEER 12 Units

EERs for properly sized AC2 units can be compared to standard air cooled condenser units of the same size as long as the manufacturer's data are corrected to real fan watt draws, sensible heat ratios, and cycling losses. Figure 4-6 compares the average performance of the four units with the performance of typical SEER 10 and SEER 12 units under the same conditions.

The improved performance of the AC2 unit at higher temperatures results in substantial energy savings as well as peak reductions for the utility. Table 4-2 shows the energy consumption difference at various outdoor temperatures.
